Access Compliance Report

Public Rights-of-Way

(Curb Ramps)

Intersection ID: 5848	Main Street: HELLEBORE_RD	Cross Street: PHLOX_CT	Location: NW
ADA ID: 09C0DA241FA8	Ramp Type: Perp	Initial Pass/Fail: Fail	Overall Compliance: No
Severity Score: 46.25			
Codes/Mitigation Info/Possible Solution		Field Measurements/Component Compliance

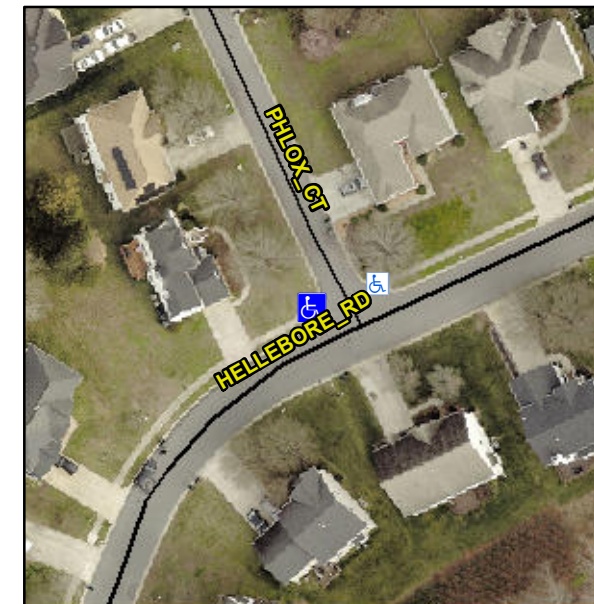
Not Found, R304.5.1, R304.2.2, R304.5.3

Compliance	Description	Data	Compliance	Description	Data
N/A	Ramp Length (in)	46.0	No	Ramp Slope (%)	8.9
No	Ramp Width (in)	44.0	No	Ramp XSlope (%)	14.0
N/A	Flare Type LT	N/A	N/A	Flare Type RT	N/A
N/A	Flare Slope LT (%)	N/A	N/A	Flare Slope RT (%)	N/A
N/A	Flare Traversable LT?	N/A	N/A	Flare Traversable RT?	N/A
N/A	Landing Length (in)	N/A	N/A	DWS Provided?	N/A
N/A	Landing Width (in)	N/A	N/A	DWS Contrast?	N/A
N/A	Landing Slope (%)	N/A	N/A	DWS Length (in)	N/A
N/A	Landing X Slope (%)	N/A	N/A	DWS Full Width?	N/A
N/A	Landing Curb? (Y/N)	N/A	N/A	DWS Offset (in)	N/A
N/A	Shared Landing?	N/A			
N/A	Gutter Ponding?	N/A	N/A	Gutter Slope (%)	N/A
N/A	Gutter Lip Ht (in)	N/A	N/A	Gutter X Slope (%)	N/A
N/A	Painted X Walk1?	No	N/A	Painted X Walk2?	N/A
	X Walk 1 Direction	To E		X Walk 2 Direction	N/A
N/A	X Walk 1 Width (in)	N/A	N/A	X Walk 2 Width (in)	N/A
	X Walk 1 Slope (%)	6.1		X Walk 2 Slope (%)	N/A
	X Walk 1 X Slope (%)	10.9		X Walk 2 X Slope (%)	N/A

N/A	Ramp inside XWalk1?	N/A	N/A	Ramp inside XWalk2?	N/A
	Road Slope (%)	N/A	N/A	Clear Space?	N/A
	Road X Slope (%)	N/A	N/A	Clear Space to XWalk (in)	N/A
N/A	Any Obstructions?	N/A	N/A	Storm Grate/Utility Hazard?	N/A
	Obstruction Type			Storm Grate/Utility Type	
		N/A			N/A
			Yes	Surface Condition? (G/P)	Good

Possible Solutions:

Remove & Replace Entire Ramp.
