# Access Compliance Report

## Public Rights-of-Way

### (Curb Ramps)

Intersection ID: 16513	Main Street: BILTMORE_DR	Cross Street: COLVILLE_RD	Location: SE
ADA ID: 09CE12ACF0EE	Ramp Type: Perp	Initial Pass/Fail: Fail	Overall Compliance: No
Severity Score: 13.75			
Codes/Mitigation Info/Possible Solution		Field Measurements/Component Compliance

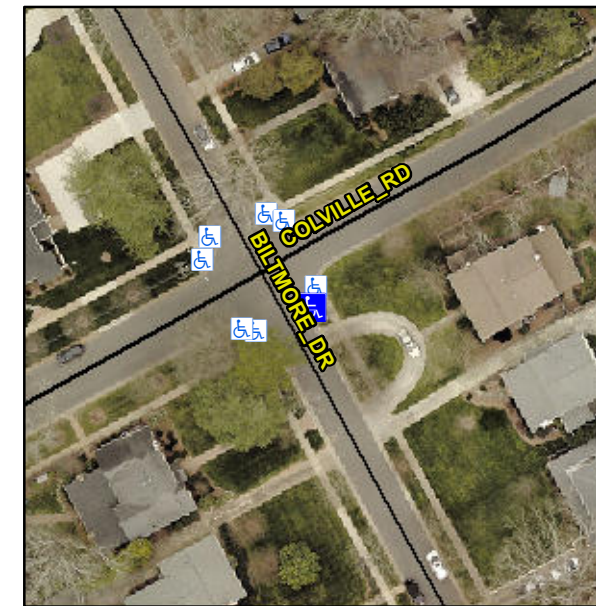
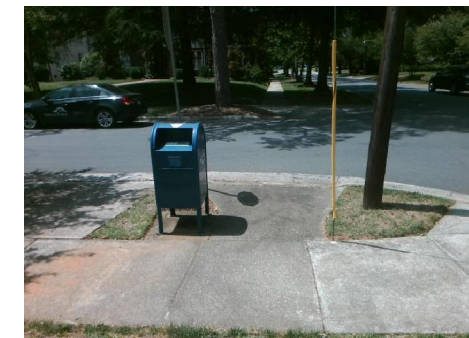
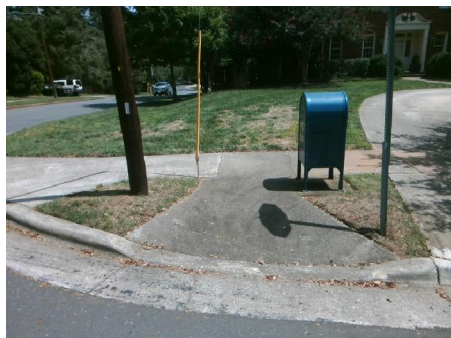
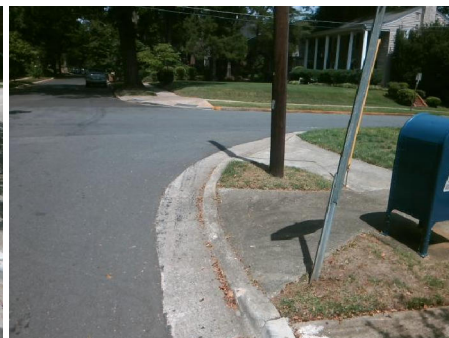
**R304.2.2, R304.5.3**

Compliance	Description	Data	Compliance	Description	Data
N/A	Ramp Length (in)	86.0	No	Ramp Slope (%)	10.4
Yes	Ramp Width (in)	54.0	No	Ramp XSlope (%)	4.0
N/A	Flare Type LT	N/A	N/A	Flare Type RT	N/A
N/A	Flare Slope LT (%)	N/A	N/A	Flare Slope RT (%)	N/A
N/A	Flare Traversable LT?	N/A	N/A	Flare Traversable RT?	N/A
N/A	Landing Length (in)	N/A	N/A	DWS Provided?	N/A
N/A	Landing Width (in)	N/A	N/A	DWS Contrast?	N/A
N/A	Landing Slope (%)	N/A	N/A	DWS Length (in)	N/A
N/A	Landing X Slope (%)	N/A	N/A	DWS Full Width?	N/A
N/A	Landing Curb? (Y/N)	N/A	N/A	DWS Offset (in)	N/A
N/A	Shared Landing?	N/A			
N/A	Gutter Ponding?	N/A	N/A	Gutter Slope (%)	N/A
N/A	Gutter Lip Ht (in)	N/A	N/A	Gutter X Slope (%)	N/A
N/A	Painted X Walk1?	No	N/A	Painted X Walk2?	N/A
	X Walk 1 Direction	To SW		X Walk 2 Direction	N/A
N/A	X Walk 1 Width (in)	N/A	N/A	X Walk 2 Width (in)	N/A
	X Walk 1 Slope (%)	2.1		X Walk 2 Slope (%)	N/A
	X Walk 1 X Slope (%)	1.4		X Walk 2 X Slope (%)	N/A

N/A	Ramp inside XWalk1?	N/A	N/A	Ramp inside XWalk2?	N/A
	Road Slope (%)	N/A	N/A	Clear Space?	N/A
	Road X Slope (%)	N/A	N/A	Clear Space to XWalk (in)	N/A
N/A	Any Obstructions?	N/A	N/A	Storm Grate/Utility Hazard?	N/A
	Obstruction Type			Storm Grate/Utility Type	
		N/A			N/A
			Yes	Surface Condition? (G/P)	Good

**Remove & Replace Entire Ramp.**

Total Cost: \$ 1850.00
