# Access Compliance Report

## Public Rights-of-Way

### (Curb Ramps)

Intersection ID: 9801	Main Street: ETHEL_GUEST_LN	Cross Street: RISING_OAK_DR	Location:	NW
ADA ID: 09E47C4FC488	Ramp Type: PerpDiag	Initial Pass/Fail: Fail	Overall Compliance: No	Severity Score: 35
Codes/Mitigation Info/Possible Solution		Field Measurements/Component Compliance

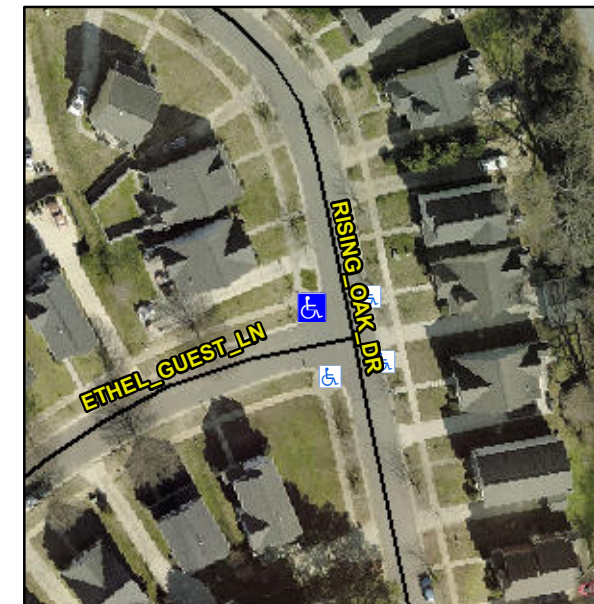
Compliance	Description	Data	Compliance	Description	Data
N/A	Ramp Length (in)	94.5	Yes	Ramp Slope (%)	5.7
No	Ramp Width (in)	30.0	Yes	Ramp XSlope (%)	0.9
N/A	Flare Type LT	N/A	N/A	Flare Type RT	N/A
N/A	Flare Slope LT (%)	N/A	N/A	Flare Slope RT (%)	N/A
N/A	Flare Traversable LT?	N/A	N/A	Flare Traversable RT?	N/A
N/A	Landing Length (in)	N/A	N/A	DWS Provided?	N/A
N/A	Landing Width (in)	N/A	N/A	DWS Contrast?	N/A
N/A	Landing Slope (%)	N/A	N/A	DWS Length (in)	N/A
N/A	Landing X Slope (%)	N/A	N/A	DWS Full Width?	N/A
N/A	Landing Curb? (Y/N)	N/A	N/A	DWS Offset (in)	N/A
N/A	Shared Landing?	N/A			
N/A	Gutter Ponding?	N/A	N/A	Gutter Slope (%)	N/A
N/A	Gutter Lip Ht (in)	0.5	N/A	Gutter X Slope (%)	N/A
N/A	Painted X Walk1?	No	N/A	Painted X Walk2?	No
	X Walk 1 Direction	To E		X Walk 2 Direction	To S
N/A	X Walk 1 Width (in)	N/A	N/A	X Walk 2 Width (in)	N/A
	X Walk 1 Slope (%)	2.9		X Walk 2 Slope (%)	2.8
	X Walk 1 X Slope (%)	1.6		X Walk 2 X Slope (%)	3.9

N/A	Ramp inside XWalk1?	N/A	N/A	Ramp inside XWalk2?	N/A
	Road Slope (%)	1.9	N/A	Clear Space?	N/A
	Road X Slope (%)	6.0	N/A	Clear Space to XWalk (in)	N/A
N/A	Any Obstructions?	N/A	N/A	Storm Grate/Utility Hazard?	N/A
	Obstruction Type			Storm Grate/Utility Type	
		N/A			N/A
		Yes		Surface Condition? (G/P)	Good

**Remove & Replace Curb Ramp With Two New Directional Ramps or Equivalent.**

**Not Found, R304.5.1**
