# Access Compliance Report

## Public Rights-of-Way

Intersection ID: 10039540	Main Street: THERMAL_RD	Cross Street: N/A	Location: NW
ADA ID: 09E5E64EFF31	Ramp Type: Directional1	Initial Pass/Fail: Fail	Overall Compliance: No
		Severity Score: 22.5

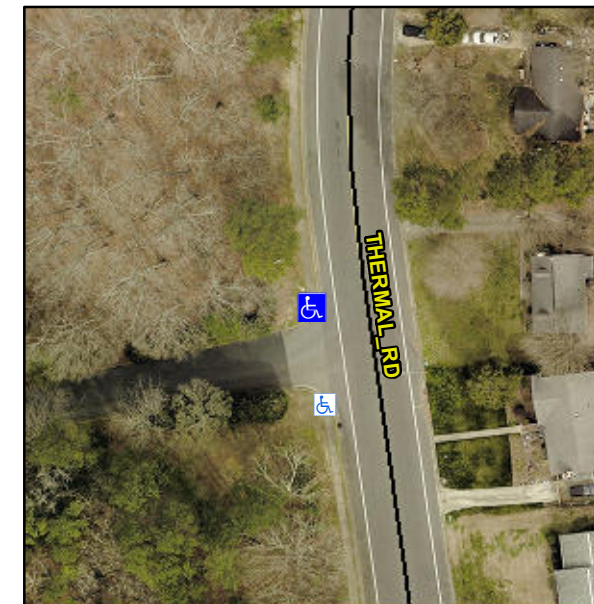
**ASP LIP 1.5", CURB LIP 1.0"**

**R304.5.1, R304.2.2**

Compliance	Description	Data	Compliance	Description	Data
N/A	Ramp Length (in)	61.0	N/A	Grade Break?	N/A
No	Ramp Width (in)	47.5	N/A	Grade Break Slope (%)	0.0
No	Ramp Slope (%)	10.2	N/A	Grade Break XSlope (%)	0.0
Yes	Ramp XSlope (%)	2.6			
N/A	Flare Type LT	N/A	N/A	Flare Type RT	N/A
N/A	Flare Slope LT (%)	N/A	N/A	Flare Slope RT (%)	0.0
N/A	Flare Traversable LT?	N/A	N/A	Flare Traversable RT?	N/A
N/A	Landing Length (in)	0.0	N/A	DWS Provided?	N/A
N/A	Landing Width (in)	0.0	N/A	DWS Contrast?	N/A
N/A	Landing Slope (%)	0.0	N/A	DWS Length (in)	N/A
N/A	Landing X Slope (%)	0.0	N/A	DWS Full Width?	N/A
N/A	Landing Curb? (Y/N)	N/A	N/A	DWS Offset LT (in)	N/A
N/A	Shared Landing?	N/A	N/A	DWS Offset RT (in)	N/A
N/A	Gutter Ponding?	0.0	N/A	Gutter Slope (%)	N/A
N/A	Gutter Lip Ht (in)	0.0	N/A	Gutter X Slope (%)	N/A
N/A	Painted X Walk1?	No		Road Slope (%)	3.8
	X Walk 1 Direction	To SE		Road X Slope (%)	5.1
	X Walk 1 Width (in)	N/A		Clear Space?	N/A

X Walk 1 Slope (%)	3.8	N/A	Clear Space to XWalk (in)	N/A
	X Walk 1 X Slope (%)	5.1	N/A	Storm Grate/Utility Hazard?	N/A
N/A	Ramp inside XWalk1?	N/A		Storm Grate/Utility Type	
N/A	Any Obstructions?	N/A			N/A
	Obstruction Type		Yes	Surface Condition? (G/P)	Good
			N/A	Curb Slope (%)	8.7

Possible Solutions:

**Remove & Replace Entire Ramp.**
