Access Compliance Report

Public Rights-of-Way

(Curb Ramps)

Intersection ID: 3067	Main Street: HEDGE_MAPLE_RD	Cross Street: PLACER_MAPLE_LN	Location:	N
ADA ID: 09EB5AFB44A7	Ramp Type: Perp	Initial Pass/Fail: Fail	Overall Compliance: No	Severity Score: 10
Codes/Mitigation Info/Possible Solution		Field Measurements/Component Compliance

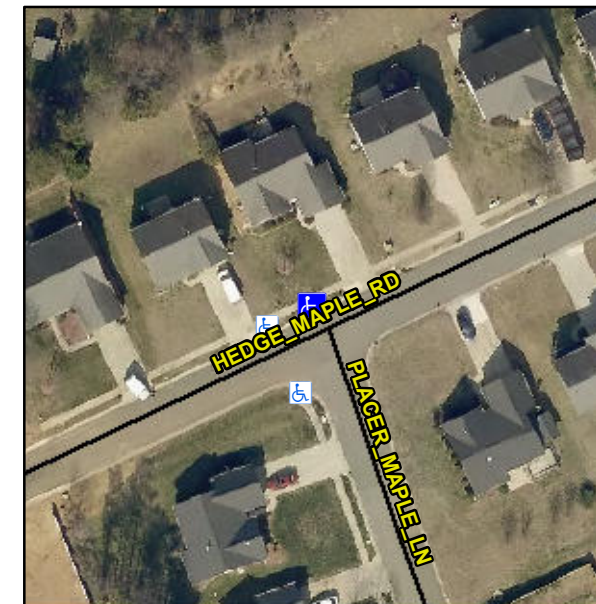
Not Found, R304.5.1, R304.5.3

Compliance	Description	Data	Compliance	Description	Data
N/A	Ramp Length (in)	49.0	Yes	Ramp Slope (%)	6.8
No	Ramp Width (in)	44.0	No	Ramp XSlope (%)	4.2
N/A	Flare Type LT	N/A	N/A	Flare Type RT	N/A
N/A	Flare Slope LT (%)	N/A	N/A	Flare Slope RT (%)	N/A
N/A	Flare Traversable LT?	N/A	N/A	Flare Traversable RT?	N/A
N/A	Landing Length (in)	N/A	N/A	DWS Provided?	N/A
N/A	Landing Width (in)	N/A	N/A	DWS Contrast?	N/A
N/A	Landing Slope (%)	N/A	N/A	DWS Length (in)	N/A
N/A	Landing X Slope (%)	N/A	N/A	DWS Full Width?	N/A
N/A	Landing Curb? (Y/N)	N/A	N/A	DWS Offset (in)	N/A
N/A	Shared Landing?	N/A			
N/A	Gutter Ponding?	N/A	N/A	Gutter Slope (%)	N/A
N/A	Gutter Lip Ht (in)	N/A	N/A	Gutter X Slope (%)	N/A
N/A	Painted X Walk1?	No	N/A	Painted X Walk2?	N/A
	X Walk 1 Direction	To SW		X Walk 2 Direction	N/A
N/A	X Walk 1 Width (in)	N/A	N/A	X Walk 2 Width (in)	N/A
	X Walk 1 Slope (%)	2.6		X Walk 2 Slope (%)	N/A
	X Walk 1 X Slope (%)	4.1		X Walk 2 X Slope (%)	N/A

N/A	Ramp inside XWalk1?	N/A	N/A	Ramp inside XWalk2?	N/A
	Road Slope (%)	N/A	N/A	Clear Space?	N/A
	Road X Slope (%)	N/A	N/A	Clear Space to XWalk (in)	N/A
N/A	Any Obstructions?	N/A	N/A	Storm Grate/Utility Hazard?	N/A
	Obstruction Type			Storm Grate/Utility Type	
		N/A			N/A
			Yes	Surface Condition? (G/P)	Good

Possible Solutions:

Remove & Replace Entire Ramp.
