Access Compliance Report

Public Rights-of-Way

(Curb Ramps)

Intersection ID: 3159	Main Street: DAUPHINE_DR	Cross Street: MAGENNIS_GROVE_CT	Location:	N
ADA ID: 0A0FF86E696D	Ramp Type: Perp	Initial Pass/Fail: Fail	Overall Compliance: No	Severity Score: 1.25
Codes/Mitigation Info/Possible Solution		Field Measurements/Component Compliance

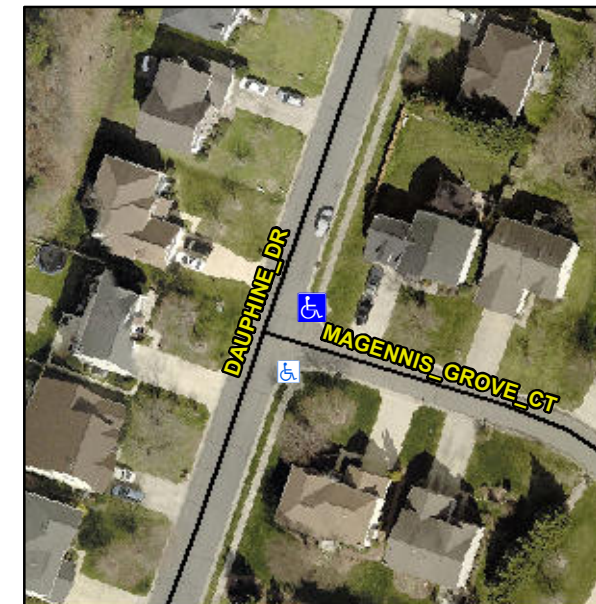
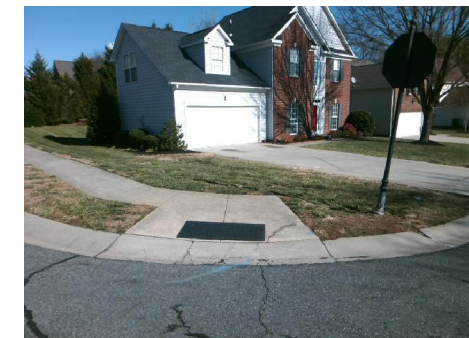
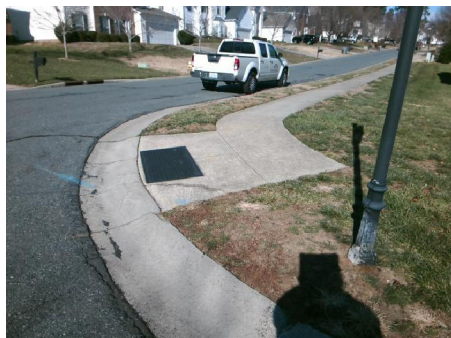
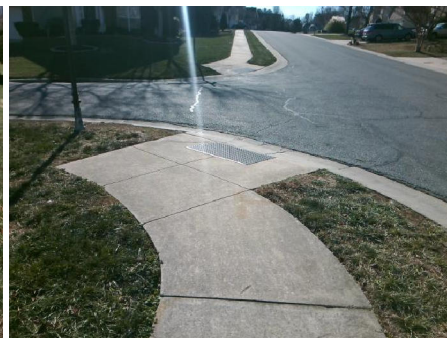
Not Found, R304.5.3

Compliance	Description	Data	Compliance	Description	Data
N/A	Ramp Length (in)	51.0	Yes	Ramp Slope (%)	5.7
Yes	Ramp Width (in)	48.0	No	Ramp XSlope (%)	4.6
N/A	Flare Type LT	N/A	N/A	Flare Type RT	N/A
N/A	Flare Slope LT (%)	N/A	N/A	Flare Slope RT (%)	N/A
N/A	Flare Traversable LT?	N/A	N/A	Flare Traversable RT?	N/A
N/A	Landing Length (in)	N/A	N/A	DWS Provided?	N/A
N/A	Landing Width (in)	N/A	N/A	DWS Contrast?	N/A
N/A	Landing Slope (%)	N/A	N/A	DWS Length (in)	N/A
N/A	Landing X Slope (%)	N/A	N/A	DWS Full Width?	N/A
N/A	Landing Curb? (Y/N)	N/A	N/A	DWS Offset (in)	N/A
N/A	Shared Landing?	N/A			
N/A	Gutter Ponding?	N/A	N/A	Gutter Slope (%)	N/A
N/A	Gutter Lip Ht (in)	N/A	N/A	Gutter X Slope (%)	N/A
N/A	Painted X Walk1?	No	N/A	Painted X Walk2?	N/A
	X Walk 1 Direction	To SW		X Walk 2 Direction	N/A
N/A	X Walk 1 Width (in)	N/A	N/A	X Walk 2 Width (in)	N/A
	X Walk 1 Slope (%)	2.1		X Walk 2 Slope (%)	N/A
	X Walk 1 X Slope (%)	5.7		X Walk 2 X Slope (%)	N/A

Remove & Replace Entire Ramp.
