## **Access Compliance Report Public Rights-of-Way** (Curb Ramps)

Intersection ID: 53350 Main Street: SAPPHIRE\_HILL\_LN **Cross Street: LOST CANYON WY** Location: NW ADA ID: 0A1F15212D56 Ramp Type: BlendTrans1 Initial Pass/Fail: Fail **Overall Compliance: No Severity Score:** 1.25

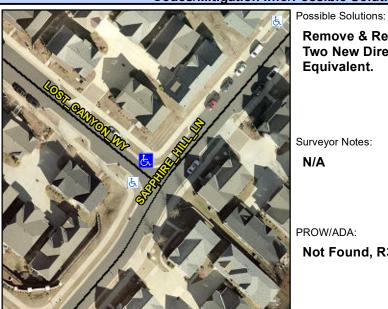
Not Found, R304.5.3

N/A	Ramp Length (in)	91.0	Yes	BlendTrans Slope (%)	1.2
Yes	Ramp Width (in)	59.0	No	BlendTrans XSlope (%)	3.7
N/A	Flare Type LT	N/A	N/A	Flare Type RT	N/A
N/A	Flare Slope LT (%)	N/A	N/A	Flare Slope RT (%)	N/A
N/A	Flare Traversable LT?	N/A	N/A	Flare Traversable RT?	N/A
N/A	Landing Length (in)	N/A	N/A	DWS Provided?	N/A
N/A	Landing Width (in)	N/A	N/A	DWS Contrast?	N/A
N/A	Landing Slope (%)	N/A	N/A	DWS Length (in)	N/A
N/A	Landing X Slope (%)	N/A	N/A	DWS Full Width?	N/A
N/A	Landing Curb? (Y/N)	N/A	N/A	DWS Offset (in)	N/A
N/A	Shared Landing?	N/A			
N/A	Gutter Ponding?	N/A	N/A	Gutter Slope (%)	N/A
N/A	Gutter Lip Ht (in)	N/A	N/A	Gutter X Slope (%)	N/A
N/A	Painted X Walk1?	No	N/A	Painted X Walk2?	N/A
	X Walk 1 Direction	To SW		X Walk 2 Direction	N/A
	X Walk 1 Width (in)	N/A		X Walk 2 Width (in)	N/A
	X Walk 1 Slope (%)	2.5		X Walk 2 Slope (%)	N/A
	X Walk 1 X Slope (%)	5.1		X Walk 2 X Slope (%)	N/A
N/A	Ramp inside XWalk1?	N/A	N/A	Ramp inside XWalk2?	N/A

Road Slope (%)	5.1		Clear Space?	N/A
	Road X Slope (%)	2.5	N/A	Clear Space to XWalk (in)	N/A
N/A	Any Obstructions?	N/A	N/A	Storm Grate/Utility Hazard?	N/A
	Obstruction Type		l	Storm Grate/Utility Type	
		N/A			N/A
			Yes	Surface Condition? (G/P)	Good
			No	Curb Slope (%)	6.4

Remove & Replace Curb Ramp With Two New Directional Ramps or Equivalent.
