Access Compliance Report

Public Rights-of-Way

(Curb Ramps)

Intersection ID: 10468	Main Street: E_35TH_ST	Cross Street: WHITING_AV	Location: NW
ADA ID: 0A2EA07E6312	Ramp Type: Perp	Initial Pass/Fail: Fail	Overall Compliance: No
Severity Score: 22.5			
Codes/Mitigation Info/Possible Solution		Field Measurements/Component Compliance

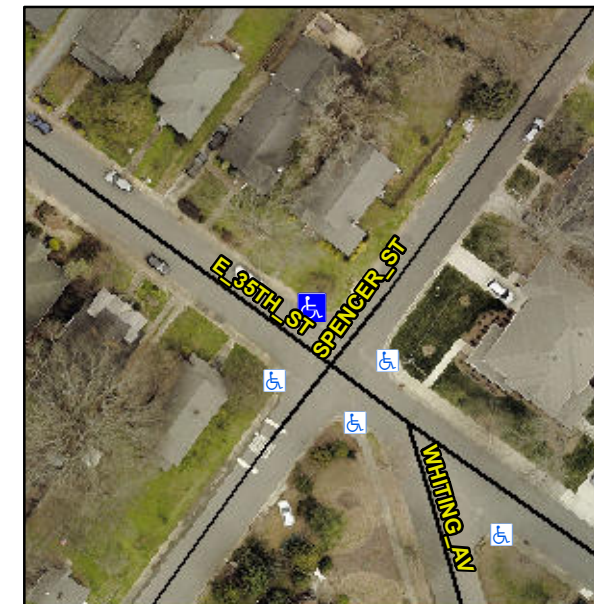
PROW/ADA:

Not Found, R304.5.1, R304.2.2

Compliance	Description	Data	Compliance	Description	Data
N/A	Ramp Length (in)	52.0	No	Ramp Slope (%)	11.1
No	Ramp Width (in)	46.0	Yes	Ramp XSlope (%)	2.2
N/A	Flare Type LT	N/A	N/A	Flare Type RT	N/A
N/A	Flare Slope LT (%)	N/A	N/A	Flare Slope RT (%)	N/A
N/A	Flare Traversable LT?	N/A	N/A	Flare Traversable RT?	N/A
N/A	Landing Length (in)	N/A	N/A	DWS Provided?	N/A
N/A	Landing Width (in)	N/A	N/A	DWS Contrast?	N/A
N/A	Landing Slope (%)	N/A	N/A	DWS Length (in)	N/A
N/A	Landing X Slope (%)	N/A	N/A	DWS Full Width?	N/A
N/A	Landing Curb? (Y/N)	N/A	N/A	DWS Offset (in)	N/A
N/A	Shared Landing?	N/A			
N/A	Gutter Ponding?	N/A	N/A	Gutter Slope (%)	N/A
N/A	Gutter Lip Ht (in)	1.5	N/A	Gutter X Slope (%)	N/A
N/A	Painted X Walk1?	No	N/A	Painted X Walk2?	N/A
	X Walk 1 Direction	To SE		X Walk 2 Direction	N/A
N/A	X Walk 1 Width (in)	N/A	N/A	X Walk 2 Width (in)	N/A
	X Walk 1 Slope (%)	4.1		X Walk 2 Slope (%)	N/A
	X Walk 1 X Slope (%)	3.1		X Walk 2 X Slope (%)	N/A

N/A	Ramp inside XWalk1?	N/A	N/A	Ramp inside XWalk2?	N/A
	Road Slope (%)	N/A	N/A	Clear Space?	N/A
	Road X Slope (%)	N/A	N/A	Clear Space to XWalk (in)	N/A
N/A	Any Obstructions?	N/A	N/A	Storm Grate/Utility Hazard?	N/A
	Obstruction Type			Storm Grate/Utility Type	
		N/A			N/A
		Yes		Surface Condition? (G/P)	Good

Possible Solutions:

Remove & Replace Entire Ramp.

Total Cost: \$ 1850.00
