# Access Compliance Report

## Public Rights-of-Way

### (Curb Ramps)

| Intersection ID: 51356 | Main Street: BRENTMOOR_DR | Cross Street: PEARL_ST | Location: NW |

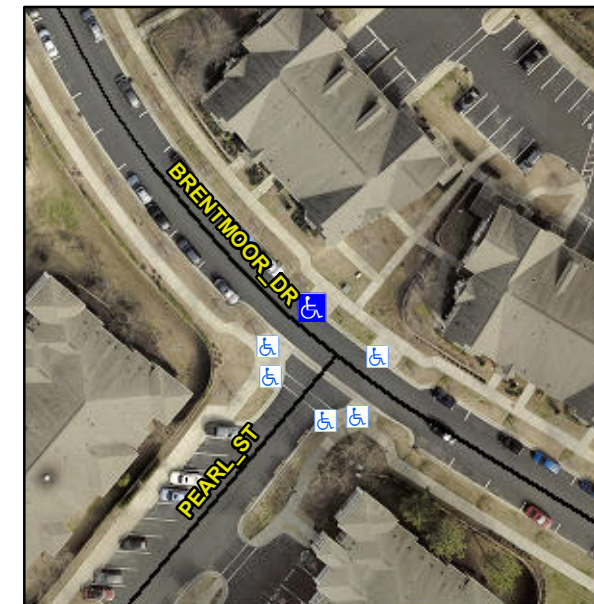
| ADA ID: 0A30723EFF77 | Ramp Type: BlendTrans1 | Initial Pass/Fail: Fail | Overall Compliance: No |
| Severity Score: 12.5 | | | |

**Not Found, R304.5.3**

| Compliance | Description | Data | Compliance | Description | Data |
|---|---|---|---|---|---|
| Yes | Ramp Width (in) | 48.0 | No | BlendTrans XSlope (%) | 5.3 |
| | | | No | Curb Slope (%) | 25.3 |

**Remove & Replace Curb Ramp With Two New Directional Ramps or Equivalent.**

Total Cost: \$ 3200.00
