Access Compliance Report

Public Rights-of-Way

(Curb Ramps)

Intersection ID: 9655	Main Street: N_GRAHAM_ST	Cross Street: CONCORDIA_AV	Location: E
ADA ID: 0A3B3F16E958	Ramp Type: PerpDiag	Initial Pass/Fail: Fail	Overall Compliance: No
Codes/Mitigation Info/Possible Solution		Field Measurements/Component Compliance	
Severity Score: 48.75

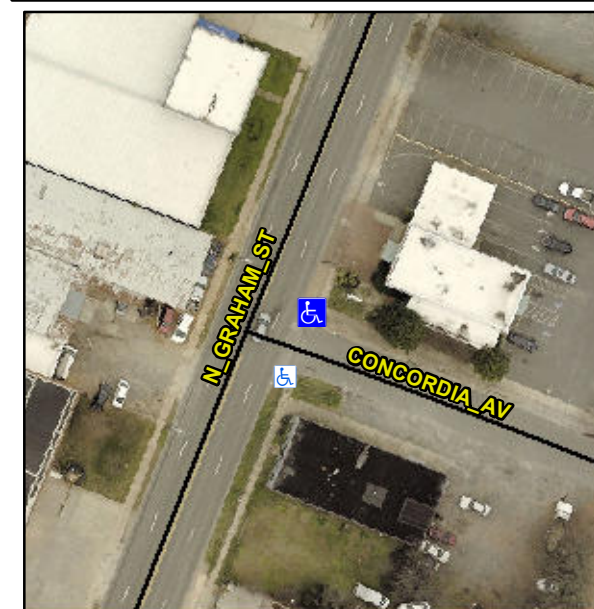
Not Found, R304.5.1, R304.2.2, R302.7

Compliance	Description	Data	Compliance	Description	Data
N/A	Ramp Length (in)	29.5	No	Ramp Slope (%)	12.9
No	Ramp Width (in)	47.5	Yes	Ramp XSlope (%)	1.6
N/A	Flare Type LT	N/A	N/A	Flare Type RT	N/A
N/A	Flare Slope LT (%)	N/A	N/A	Flare Slope RT (%)	N/A
N/A	Flare Traversable LT?	N/A	N/A	Flare Traversable RT?	N/A
N/A	Landing Length (in)	N/A	N/A	DWS Provided?	N/A
N/A	Landing Width (in)	N/A	N/A	DWS Contrast?	N/A
N/A	Landing Slope (%)	N/A	N/A	DWS Length (in)	N/A
N/A	Landing X Slope (%)	N/A	N/A	DWS Full Width?	N/A
N/A	Landing Curb? (Y/N)	N/A	N/A	DWS Offset (in)	N/A
N/A	Shared Landing?	N/A			
N/A	Gutter Ponding?	Yes	N/A	Gutter Slope (%)	N/A
N/A	Gutter Lip Ht (in)	N/A	N/A	Gutter X Slope (%)	N/A
N/A	Painted X Walk1?	No	N/A	Painted X Walk2?	No
	X Walk 1 Direction	To NW		X Walk 2 Direction	To SW
N/A	X Walk 1 Width (in)	N/A	N/A	X Walk 2 Width (in)	N/A
	X Walk 1 Slope (%)	5.8		X Walk 2 Slope (%)	3.0
	X Walk 1 X Slope (%)	0.8		X Walk 2 X Slope (%)	2.4

N/A	Ramp inside XWalk1?	N/A	N/A	Ramp inside XWalk2?	N/A
	Road Slope (%)	2.5	N/A	Clear Space?	N/A
	Road X Slope (%)	3.7	N/A	Clear Space to XWalk (in)	N/A
N/A	Any Obstructions?	N/A	N/A	Storm Grate/Utility Hazard?	N/A
	Obstruction Type			Storm Grate/Utility Type	
		N/A			N/A
		No		Surface Condition? (G/P)	Poor

Remove & Replace Curb Ramp With Two New Directional Ramps or Equivalent.

Total Cost: \$ 3200.00
