Access Compliance Report

Public Rights-of-Way

(Curb Ramps)

Intersection ID: 7225	Main Street: STATESVILLE_RD	Cross Street: STARITA_RD	Location: SE
ADA ID: 0A5F2205F8F1	Ramp Type: Para	Initial Pass/Fail: Fail	Overall Compliance: No
Codes/Mitigation Info/Possible Solution		Field Measurements/Component Compliance	
Severity Score: 13.75

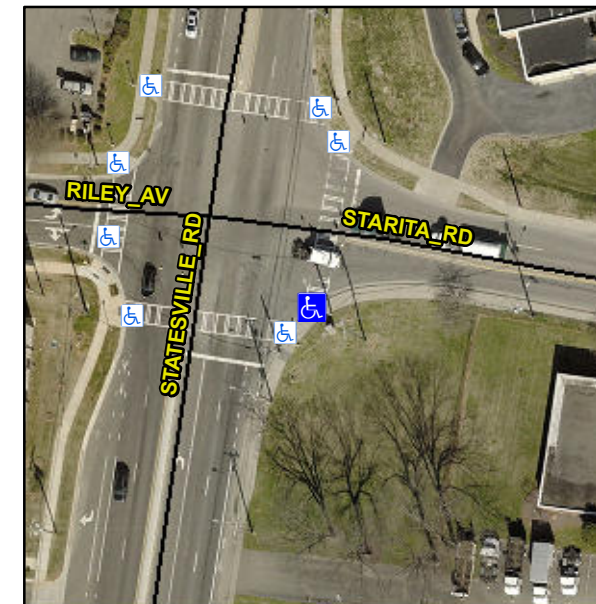
CURB GAP 1.0, LT RP < 5%

R304.5.3, R304.3.2

Compliance	Description	Data	Compliance	Description	Data
N/A	Ramp Length LT (in)	62.0	N/A	Ramp Length RT (in)	63.5
Yes	Ramp Width LT (in)	59.0	Yes	Ramp Width RT (in)	84.5
Yes	Ramp Slope LT (%)	4.8	No	Ramp Slope RT (%)	9.9
No	Ramp XSlope LT (%)	2.2	No	Ramp XSlope RT (%)	2.9
N/A	Landing Length (in)	N/A	N/A	DWS Provided?	N/A
N/A	Landing Width (in)	N/A	N/A	DWS Contrast?	N/A
N/A	Landing Slope (%)	N/A	N/A	DWS Length (in)	N/A
N/A	Landing X Slope (%)	N/A	N/A	DWS Full Width?	N/A
N/A	Landing Curb? (Y/N)	N/A	N/A	DWS Offset (in)	N/A
N/A	Shared Landing?	N/A			
N/A	Gutter Ponding?	N/A	N/A	Gutter Slope (%)	N/A
N/A	Gutter Lip Ht (in)	N/A	N/A	Gutter X Slope (%)	N/A
N/A	Painted X Walk1?	Yes	N/A	Painted X Walk2?	N/A
	X Walk 1 Direction	To N		X Walk 2 Direction	N/A
N/A	X Walk 1 Width (in)	110.0	N/A	X Walk 2 Width (in)	N/A
	X Walk 1 Slope (%)	0.1		X Walk 2 Slope (%)	N/A
	X Walk 1 X Slope (%)	4.4		X Walk 2 X Slope (%)	N/A
N/A	Ramp inside XWalk1?	Yes	N/A	Ramp inside XWalk2?	N/A

Road Slope (%)	N/A	N/A	Clear Space?	N/A
	Road X Slope (%)	N/A	N/A	Clear Space to XWalk (in)	N/A
N/A	Any Obstructions?	N/A	N/A	Storm Grate/Utility Hazard?	N/A
	Obstruction Type			Storm Grate/Utility Type	
		N/A			N/A
			Yes	Surface Condition? (G/P)	Good
			N/A	Curb Slope (%)	6.4

Possible Solutions:

Remove & Replace Entire Ramp.
