# Access Compliance Report

## Public Rights-of-Way

### (Curb Ramps)

Intersection ID: 28071	Main Street: PINE_VALLEY_CLUB_DR	Cross Street: PROVIDENCE_COUNTRY_CLUB_DR	Location: NE
ADA ID: 0A67625F6894	Ramp Type: Perp	Initial Pass/Fail: Fail	Overall Compliance: No
Severity Score: 1.25			
Codes/Mitigation Info/Possible Solution		Field Measurements/Component Compliance

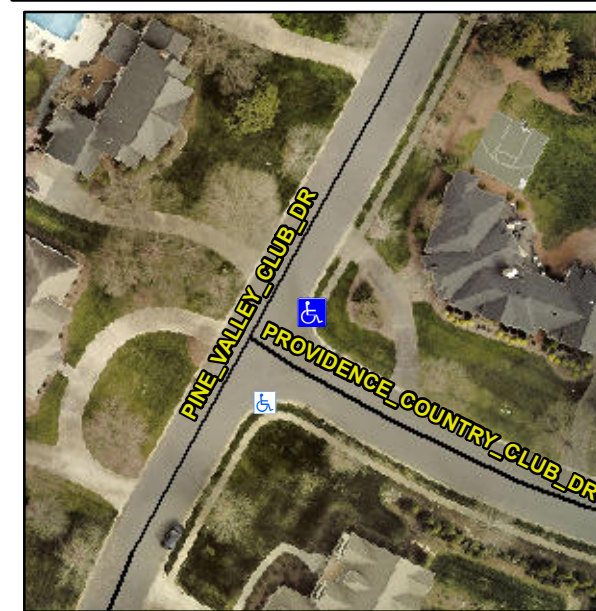
**Not Found, R304.5.3**

Compliance	Description	Data	Compliance	Description	Data
N/A	Ramp Length (in)	37.0	Yes	Ramp Slope (%)	5.4
Yes	Ramp Width (in)	48.0	No	Ramp XSlope (%)	2.4
N/A	Flare Type LT	N/A	N/A	Flare Type RT	N/A
N/A	Flare Slope LT (%)	N/A	N/A	Flare Slope RT (%)	N/A
N/A	Flare Traversable LT?	N/A	N/A	Flare Traversable RT?	N/A
N/A	Landing Length (in)	N/A	N/A	DWS Provided?	N/A
N/A	Landing Width (in)	N/A	N/A	DWS Contrast?	N/A
N/A	Landing Slope (%)	N/A	N/A	DWS Length (in)	N/A
N/A	Landing X Slope (%)	N/A	N/A	DWS Full Width?	N/A
N/A	Landing Curb? (Y/N)	N/A	N/A	DWS Offset (in)	N/A
N/A	Shared Landing?	N/A			
N/A	Gutter Ponding?	N/A	N/A	Gutter Slope (%)	N/A
N/A	Gutter Lip Ht (in)	N/A	N/A	Gutter X Slope (%)	N/A
N/A	Painted X Walk1?	No	N/A	Painted X Walk2?	N/A
	X Walk 1 Direction	To SW		X Walk 2 Direction	N/A
N/A	X Walk 1 Width (in)	N/A	N/A	X Walk 2 Width (in)	N/A
	X Walk 1 Slope (%)	4.2		X Walk 2 Slope (%)	N/A
	X Walk 1 X Slope (%)	4.2		X Walk 2 X Slope (%)	N/A

N/A	Ramp inside XWalk1?	N/A	N/A	Ramp inside XWalk2?	N/A
	Road Slope (%)	N/A	N/A	Clear Space?	N/A
	Road X Slope (%)	N/A	N/A	Clear Space to XWalk (in)	N/A
N/A	Any Obstructions?	N/A	N/A	Storm Grate/Utility Hazard?	N/A
	Obstruction Type			Storm Grate/Utility Type	
		N/A			N/A
		Yes		Surface Condition? (G/P)	Good

Possible Solutions:

**Remove & Replace Entire Ramp.**

Total Cost: \$ 1850.00
