## **Access Compliance Report Public Rights-of-Way** (Curb Ramps)

Intersection ID: 50532 Main Street: STRAUSE DR Cross Street: SAMLEN\_LN Location: NW **Overall Compliance: No** ADA ID: 0A7C50CD141F Ramp Type: PerpDiag Initial Pass/Fail: Fail **Severity Score:** 10

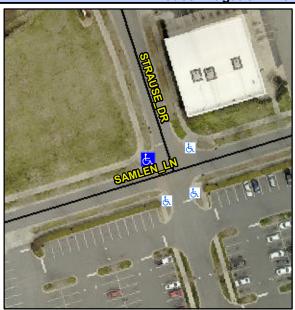
Field Measurements/Component Compliance						
Compliance Description		Data	Comp	liance Description	Data	
N/A	Ramp Length (in)	95.0	Yes	Ramp Slope (%)	5.7	
No	Ramp Width (in)	42.0	No	Ramp XSlope (%)	2.2	
N/A	Flare Type LT	N/A	N/A	Flare Type RT	N/A	
N/A	Flare Slope LT (%)	N/A	N/A	Flare Slope RT (%)	N/A	
N/A	Flare Traversable LT?	N/A	N/A	Flare Traversable RT?	N/A	
N/A	Landing Length (in)	N/A	N/A	DWS Provided?	N/A	
N/A	Landing Width (in)	N/A	N/A	DWS Contrast?	N/A	
N/A	Landing Slope (%)	N/A	N/A	DWS Length (in)	N/A	
N/A	Landing X Slope (%)	N/A	N/A	DWS Full Width?	N/A	
N/A	Landing Curb? (Y/N)	N/A	N/A	DWS Offset (in)	N/A	
N/A	Shared Landing?	N/A				
N/A	Gutter Ponding?	N/A	N/A	Gutter Slope (%)	N/A	
N/A	Gutter Lip Ht (in)	N/A	N/A	Gutter X Slope (%)	N/A	
N/A	Painted X Walk1?	Yes	N/A	Painted X Walk2?	Yes	
	X Walk 1 Direction	To S		X Walk 2 Direction	To E	
N/A	X Walk 1 Width (in)	122.0	N/A	X Walk 2 Width (in)	122.0	
	X Walk 1 Slope (%)	0.6		X Walk 2 Slope (%)	4.3

X Walk 1 X Slope (%)	3.3		X Walk 2 X Slope (%)	1.2	
N/A	Ramp inside XWalk1?	Yes	N/A	Ramp inside XWalk2?	Yes	
	Road Slope (%)	2.5	N/A	Clear Space?	N/A	
	Road X Slope (%)	1.1	N/A	Clear Space to XWalk (in)	N/A	
N/A	Any Obstructions?	N/A	N/A	Storm Grate/Utility Hazard?	N/A	
	Obstruction Type			Storm Grate/Utility Type		
		N/A			N/A	
			Yes	Surface Condition? (G/P)	Good

Possible Solutions:
Remove & Replace Curb Ramp With Two New Directional Ramps or Equivalent.
Surveyor Notes: N/A
PROW/ADA: Not Found, R304.5.1, R304.5.3
