Access Compliance Report Public Rights-of-Way (Curb Ramps)

Intersection ID: 27177 Main Street: PROVIDENCE RD Cross Street: MCKEE RD Location: SW								
Intersection ID: 27177 Main St	7 Main Street: PROVIDENCE_RD		Cross Street: MCKEE_RD					SW
ADA ID: 0A8BB7D081BD Ramp Type: Perp		Initial Pass/Fail: Fail Overall Compliance: No					Severity Score:	21.25
Codes/Mitigation Info/Possible Solution		Field Measurements/Component Compliance						
to the second second	Possible Solutions:	Compliance Description Data			Compliance Description Da		Data	
	Remove & Replace Entire Ramp.	I	N/A	Ramp Length (in)	74.0	No	Ramp Slope (%)	10.1
6	N		No	Ramp Width (in)	46.0	Yes	Ramp XSlope (%)	1.4
MCKELRU		I	N/A	Flare Type LT	N/A	N/A	Flare Type RT	N/A
EALLANITYNE COMMONS FY		I	N/A	Flare Slope LT (%)	N/A	N/A	Flare Slope RT (%)	N/A
BALLANDING	-	I	N/A	Flare Traversable LT?	N/A	N/A	Flare Traversable RT?	N/A
		I	N/A	Landing Length (in)	N/A	N/A	DWS Provided?	N/A
	Surveyor Notes:	I	N/A	Landing Width (in)	N/A	N/A	DWS Contrast?	N/A

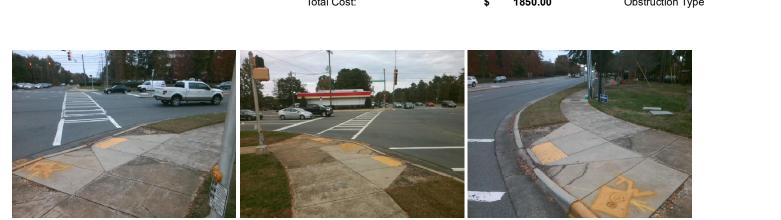
N/A	I	N/A	Landing Slope (%)	N/A	N/A	DWS Length (in)	N/A
SPACE SPACE		I	N/A	Landing X Slope (%)	N/A	N/A	DWS Full Width?	N/A
		I	N/A	Landing Curb? (Y/N)	N/A	N/A	DWS Offset (in)	N/A
	3	I	N/A	Shared Landing?	N/A			
The second se	PROW/ADA:	I	N/A	Gutter Ponding?	N/A	N/A	Gutter Slope (%)	N/A
	Not Found, R304.5.1, R304.2.2	I	N/A	Gutter Lip Ht (in)	N/A	N/A	Gutter X Slope (%)	N/A
		I	N/A	Painted X Walk1?	Yes	N/A	Painted X Walk2?	N/A
	1			X Walk 1 Direction	To E		X Walk 2 Direction	N/A
		I	N/A	X Walk 1 Width (in)	90.0	N/A	X Walk 2 Width (in)	N/A
Street 1 Name PROVIDENCE RD				X Walk 1 Slope (%)	1.5		X Walk 2 Slope (%)	N/A
Stop Condition-Street 2 Signal				X Walk 1 X Slope (%)	1.3		X Walk 2 X Slope (%)	N/A
Street 2 Name N/A		I	N/A	Ramp inside XWalk1?	Yes	N/A	Ramp inside XWalk2?	N/A
Stop Condition-Street 1 N/A				Road Slope (%)	N/A	N/A	Clear Space?	N/A
				Road X Slope (%)	N/A	N/A	Clear Space to XWalk (in)	N/A
			N/A	Any Obstructions?	N/A	N/A	Storm Grate/Utility Hazard?	N/A

Total Cost: \$ 1	850.00		Obstruction Type			Storm Grate/Utility Type	
					N/A			N/A
