# Access Compliance Report

## Public Rights-of-Way

### (Curb Ramps)

Intersection ID: 3821	Main Street: BERSHIRE_LN	Cross Street: MARBLE_HILL_DR	Location: SW
ADA ID: 0A8F75B662C9	Ramp Type: Perp	Initial Pass/Fail: Fail	Overall Compliance: No
Severity Score: 37.5			
Codes/Mitigation Info/Possible Solution		Field Measurements/Component Compliance

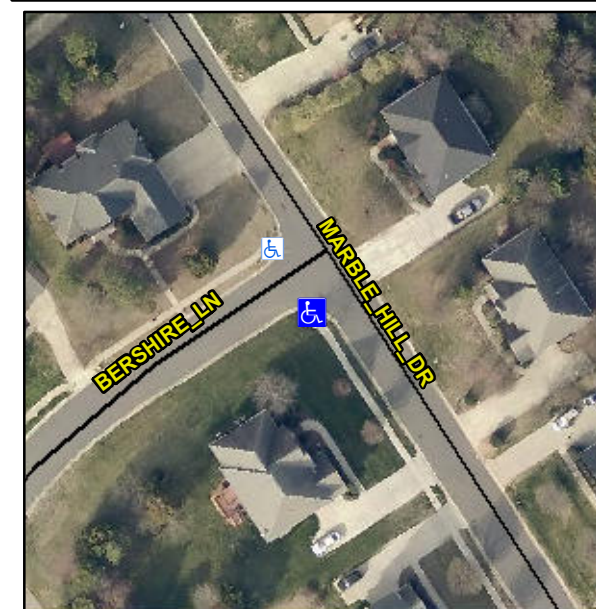
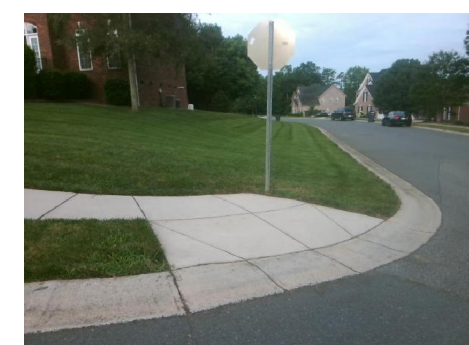
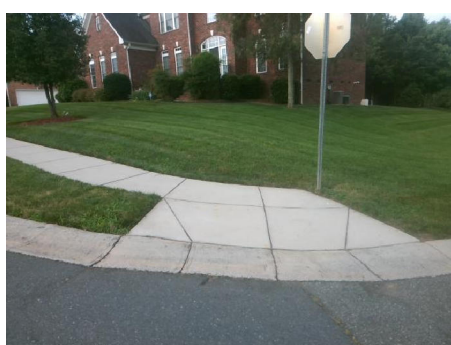
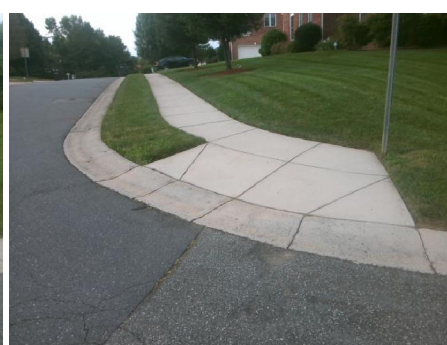
**Not Found, R304.2.2, R304.5.3**

Compliance	Description	Data	Compliance	Description	Data
N/A	Ramp Length (in)	48.0	No	Ramp Slope (%)	10.1
Yes	Ramp Width (in)	64.0	No	Ramp XSlope (%)	11.4
N/A	Flare Type LT	N/A	N/A	Flare Type RT	N/A
N/A	Flare Slope LT (%)	N/A	N/A	Flare Slope RT (%)	N/A
N/A	Flare Traversable LT?	N/A	N/A	Flare Traversable RT?	N/A
N/A	Landing Length (in)	N/A	N/A	DWS Provided?	N/A
N/A	Landing Width (in)	N/A	N/A	DWS Contrast?	N/A
N/A	Landing Slope (%)	N/A	N/A	DWS Length (in)	N/A
N/A	Landing X Slope (%)	N/A	N/A	DWS Full Width?	N/A
N/A	Landing Curb? (Y/N)	N/A	N/A	DWS Offset (in)	N/A
N/A	Shared Landing?	N/A			
N/A	Gutter Ponding?	N/A	N/A	Gutter Slope (%)	N/A
N/A	Gutter Lip Ht (in)	N/A	N/A	Gutter X Slope (%)	N/A
N/A	Painted X Walk1?	No	N/A	Painted X Walk2?	N/A
	X Walk 1 Direction	To N		X Walk 2 Direction	N/A
N/A	X Walk 1 Width (in)	N/A	N/A	X Walk 2 Width (in)	N/A
	X Walk 1 Slope (%)	6.4		X Walk 2 Slope (%)	N/A
	X Walk 1 X Slope (%)	5.8		X Walk 2 X Slope (%)	N/A

N/A	Ramp inside XWalk1?	N/A	N/A	Ramp inside XWalk2?	N/A
	Road Slope (%)	N/A	N/A	Clear Space?	N/A
	Road X Slope (%)	N/A	N/A	Clear Space to XWalk (in)	N/A
N/A	Any Obstructions?	N/A	N/A	Storm Grate/Utility Hazard?	N/A
	Obstruction Type			Storm Grate/Utility Type	
		N/A			N/A
			Yes	Surface Condition? (G/P)	Good

**Remove & Replace Entire Ramp.**

Total Cost: \$ 1850.00
