# Access Compliance Report

## Public Rights-of-Way

### (Curb Ramps)

Intersection ID: 24686	Main Street: GREENWIG_CT	Cross Street: HARLEQUIN_DR	Location: SE
ADA ID: 0A99AB5676B8	Ramp Type: Directional1	Initial Pass/Fail: Fail	Overall Compliance: No
Severity Score: 33.75			
Codes/Mitigation Info/Possible Solution		Field Measurements/Component Compliance

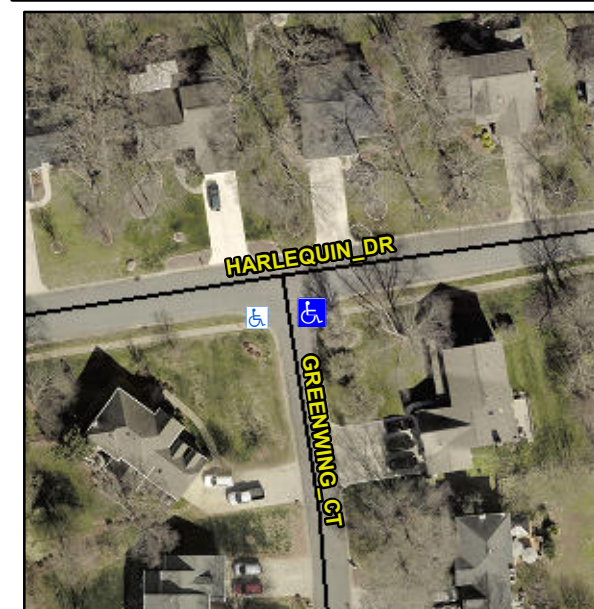
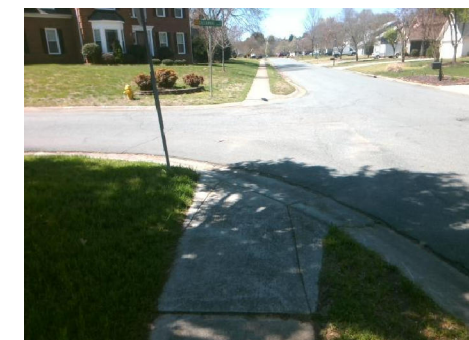
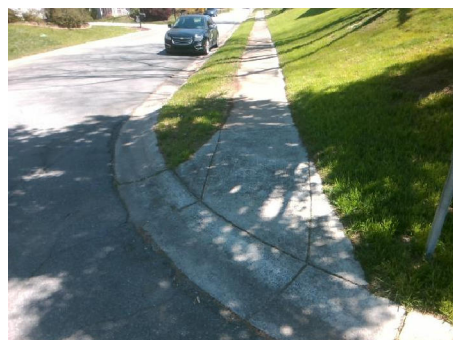
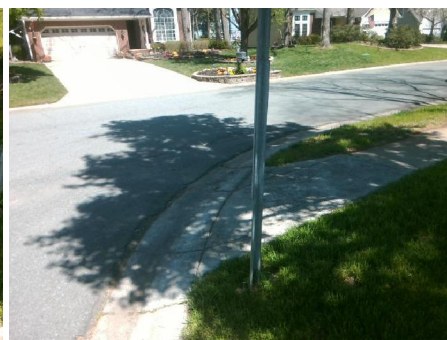
**R304.5.1, R304.5.3**

Compliance	Description	Data	Compliance	Description	Data
N/A	Ramp Length (in)	84.0	N/A	Grade Break?	N/A
No	Ramp Width (in)	43.5	N/A	Grade Break Slope (%)	0.0
Yes	Ramp Slope (%)	2.5	N/A	Grade Break XSlope (%)	0.0
No	Ramp XSlope (%)	7.5			
N/A	Flare Type LT	N/A	N/A	Flare Type RT	N/A
N/A	Flare Slope LT (%)	N/A	N/A	Flare Slope RT (%)	0.0
N/A	Flare Traversable LT?	N/A	N/A	Flare Traversable RT?	N/A
N/A	Landing Length (in)	0.0	N/A	DWS Provided?	N/A
N/A	Landing Width (in)	0.0	N/A	DWS Contrast?	N/A
N/A	Landing Slope (%)	0.0	N/A	DWS Length (in)	N/A
N/A	Landing X Slope (%)	0.0	N/A	DWS Full Width?	N/A
N/A	Landing Curb? (Y/N)	N/A	N/A	DWS Offset LT (in)	N/A
N/A	Shared Landing?	N/A	N/A	DWS Offset RT (in)	N/A
N/A	Gutter Ponding?	0.0	N/A	Gutter Slope (%)	N/A
N/A	Gutter Lip Ht (in)	0.0	N/A	Gutter X Slope (%)	N/A
N/A	Painted X Walk1?	No		Road Slope (%)	1.1
	X Walk 1 Direction	To SW		Road X Slope (%)	1.2
	X Walk 1 Width (in)	N/A		Clear Space?	N/A

X Walk 1 Slope (%)	1.1	N/A	Clear Space to XWalk (in)	N/A
	X Walk 1 X Slope (%)	1.2	N/A	Storm Grate/Utility Hazard?	N/A
N/A	Ramp inside XWalk1?	N/A		Storm Grate/Utility Type	
N/A	Any Obstructions?	N/A			N/A
	Obstruction Type		Yes	Surface Condition? (G/P)	Good
			N/A	Curb Slope (%)	9.9

**Remove & Replace Entire Ramp.**

\$ 1600.00
