# Access Compliance Report

## Public Rights-of-Way

### (Curb Ramps)

Intersection ID: 12046	Main Street: S_CEDAR_ST	Cross Street: W_1ST_ST	Location:	N
ADA ID: 0A9CD41066DF	Ramp Type: Directional2	Initial Pass/Fail: Fail	Overall Compliance: No	Severity Score: 25

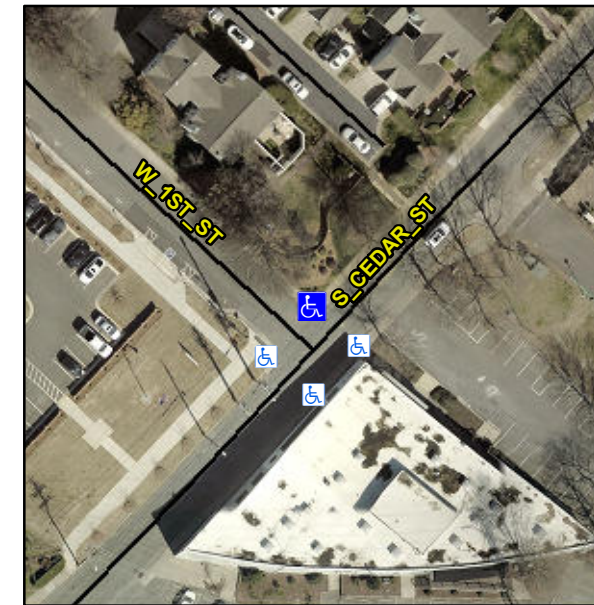
Compliance	Description	Data	Compliance	Description	Data
N/A	Ramp Length (in)	43.0	N/A	Grade Break?	N/A
Yes	Ramp Width (in)	48.0	N/A	Grade Break Slope (%)	0.0
No	Ramp Slope (%)	15.1	N/A	Grade Break XSlope (%)	0.0
Yes	Ramp XSlope (%)	1.1			
N/A	Flare Type LT	N/A	N/A	Flare Type RT	N/A
N/A	Flare Slope LT (%)	N/A	N/A	Flare Slope RT (%)	0.0
N/A	Flare Traversable LT?	N/A	N/A	Flare Traversable RT?	N/A
N/A	Landing Length (in)	0.0	N/A	DWS Provided?	N/A
N/A	Landing Width (in)	0.0	N/A	DWS Contrast?	N/A
N/A	Landing Slope (%)	0.0	N/A	DWS Length (in)	N/A
N/A	Landing X Slope (%)	0.0	N/A	DWS Full Width?	N/A
N/A	Landing Curb? (Y/N)	N/A	N/A	DWS Offset LT (in)	N/A
N/A	Shared Landing?	N/A	N/A	DWS Offset RT (in)	N/A
N/A	Gutter Ponding?	0.0	N/A	Gutter Slope (%)	N/A
N/A	Gutter Lip Ht (in)	0.0	N/A	Gutter X Slope (%)	N/A
N/A	Painted X Walk1?	No		Road Slope (%)	4.2
	X Walk 1 Direction	To SW		Road X Slope (%)	0.4
	X Walk 1 Width (in)	N/A		Clear Space?	N/A

X Walk 1 Slope (%)	4.2	N/A	Clear Space to XWalk (in)	N/A
	X Walk 1 X Slope (%)	0.4	N/A	Storm Grate/Utility Hazard?	N/A
N/A	Ramp inside XWalk1?	N/A		Storm Grate/Utility Type	
N/A	Any Obstructions?	N/A			N/A
	Obstruction Type		Yes	Surface Condition? (G/P)	Good
			N/A	Curb Slope (%)	12.6

Possible Solutions:

**Remove & Replace Entire Ramp.**

**R304.2.2**

\$ 1800.00
