# Access Compliance Report

## Public Rights-of-Way

### (Curb Ramps)

Intersection ID: 24844		Main Street: CANVASBACK_DR		Cross Street: CHOATE_CR		Location: SE											
ADA ID: 0AA145D45F94		Ramp Type: Directional1		Initial Pass/Fail: Fail		Overall Compliance: No		Severity Score: 12.5									
Codes/Mitigation Info/Possible Solution				Field Measurements/Component Compliance													
<div>

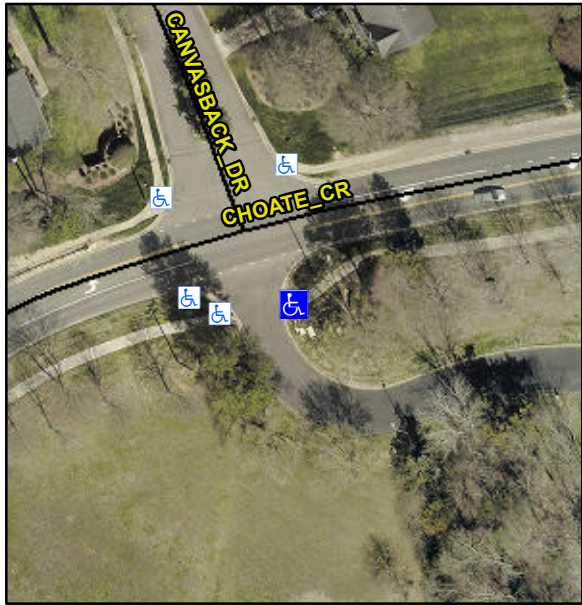
</div> <div>Street 1 NameENTRANCE</div> <div>Stop Condition-Street 1StopSign</div> <div>Street 2 NameN/A</div> <div>Stop Condition-Street 2N/A</div> <div>Possible Solutions: Remove &amp; Replace Entire Ramp.</div> <div>Surveyor Notes: N/A</div> <div>PROW/ADA: R304.2.2</div> <div>Total Cost: \$ 1600.00</div>				Compliance		Description		Data		Compliance		Description		Data			
				N/A		Ramp Length (in)		81.0		N/A		Grade Break?		N/A		N/A	
				Yes		Ramp Width (in)		73.0		N/A		Grade Break Slope (%)		0.0		0.0	
				No		Ramp Slope (%)		9.3		N/A		Grade Break XSlope (%)		0.0		0.0	
				Yes		Ramp XSlope (%)		0.5

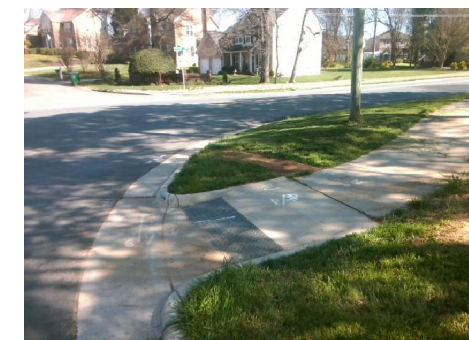
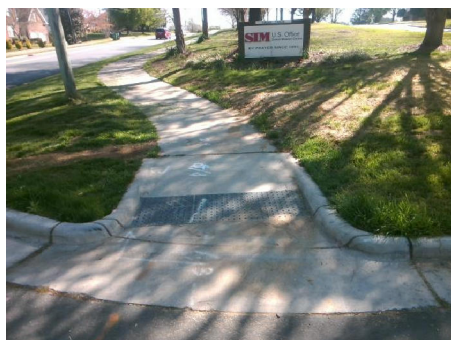
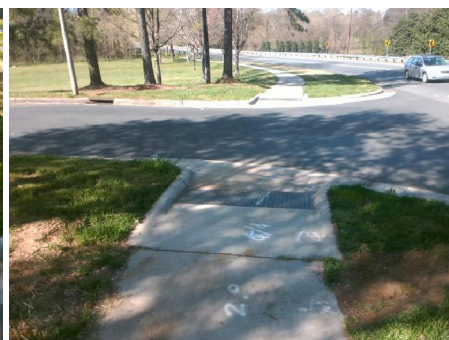
N/A		Flare Type LT		N/A		N/A		Flare Type RT		N/A		N/A	
				N/A		Flare Slope LT (%)		N/A		N/A		Flare Slope RT (%)		0.0		0.0	
				N/A		Flare Traversable LT?		N/A		N/A		Flare Traversable RT?		N/A		N/A	
				N/A		Landing Length (in)		0.0		N/A		DWS Provided?		N/A		N/A	
				N/A		Landing Width (in)		0.0		N/A		DWS Contrast?		N/A		N/A	
				N/A		Landing Slope (%)		0.0		N/A		DWS Length (in)		N/A		N/A	
				N/A		Landing X Slope (%)		0.0		N/A		DWS Full Width?		N/A		N/A	
				N/A		Landing Curb? (Y/N)		N/A		N/A		DWS Offset LT (in)		N/A		N/A	
				N/A		Shared Landing?		N/A		N/A		DWS Offset RT (in)		N/A		N/A	
				N/A		Gutter Ponding?		0.0		N/A		Gutter Slope (%)		N/A		N/A	
				N/A		Gutter Lip Ht (in)		0.0		N/A		Gutter X Slope (%)		N/A		N/A	
				N/A		Painted X Walk1?		No				Road Slope (%)		2.6		2.6	
						X Walk 1 Direction		To SW				Road X Slope (%)		1.6		1.6	
						X Walk 1 Width (in)		N/A				Clear Space?		N/A		N/A	
						X Walk 1 Slope (%)		2.6		N/A		Clear Space to XWalk (in)		N/A		N/A

X Walk 1 X Slope (%)		1.6		N/A		Storm Grate/Utility Hazard?		N/A		N/A	
				N/A		Ramp inside XWalk1?		N/A				Storm Grate/Utility Type					
				N/A		Any Obstructions?		N/A						N/A		N/A	
						Obstruction Type				Yes		Surface Condition? (G/P)		Good		Good	
										N/A		N/A		Curb Slope (%)		4.5
