## **Access Compliance Report Public Rights-of-Way** (Curb Ramps)

Intersection ID: 11497 Main Street: MARGARET BROWN ST **Cross Street: S IRWIN AV** Location: W **Overall Compliance: No Severity Score:** ADA ID: 0AA1CD1A7D3B Ramp Type: PerpDiag Initial Pass/Fail: Fail 12.5

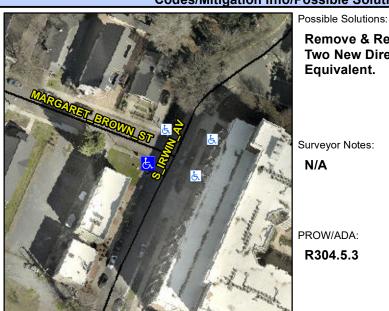
Total Cost: 3200.00 Compliance Description Data Compliance Description Data Yes N/A Ramp Length (in) 60.0 Ramp Slope (%) 6.7 No Ramp XSlope (%) Yes Ramp Width (in) 48.0 5.8 N/A N/A Flare Type LT N/A Flare Type RT N/A N/A N/A N/A Flare Slope RT (%) N/A Flare Slope LT (%) N/A Flare Traversable LT? N/A N/A Flare Traversable RT? N/A N/A N/A N/A **DWS Provided?** N/A Landing Length (in) N/A Landing Width (in) N/A N/A **DWS Contrast?** N/A N/A N/A N/A Landing Slope (%) DWS Length (in) N/A N/A Landing X Slope (%) N/A N/A DWS Full Width? N/A N/A Landing Curb? (Y/N) N/A N/A DWS Offset (in) N/A N/A N/A Shared Landing? N/A **Gutter Ponding?** N/A N/A Gutter Slope (%) N/A N/A Gutter Lip Ht (in) N/A N/A Gutter X Slope (%) N/A N/A Painted X Walk1? No N/A Painted X Walk2? No X Walk 1 Direction To SE X Walk 2 Direction To NE N/A N/A X Walk 1 Width (in) X Walk 2 Width (in) N/A X Walk 1 Slope (%) 10.0 X Walk 2 Slope (%) 3.2 X Walk 2 X Slope (%) X Walk 1 X Slope (%) 1.1 5.8 N/A N/A N/A Ramp inside XWalk2? N/A Ramp inside XWalk1? Road Slope (%) 4.3 N/A Clear Space? N/A N/A Road X Slope (%) 3.0 Clear Space to XWalk (in) N/A N/A N/A N/A Any Obstructions? Storm Grate/Utility Hazard? N/A

Equivalent.

Surveyor Notes: N/A PROW/ADA: R304.5.3

Remove & Replace Curb Ramp With Two New Directional Ramps or
