# Access Compliance Report

## Public Rights-of-Way

### (Curb Ramps)

Intersection ID: 13382	Main Street: E_CATHERINE_ST	Cross Street: S_COLLEGE_ST	Location: W
ADA ID: 0AA4136C1FC2	Ramp Type: Perp	Initial Pass/Fail: Fail	Overall Compliance: No
		Severity Score: 37.5

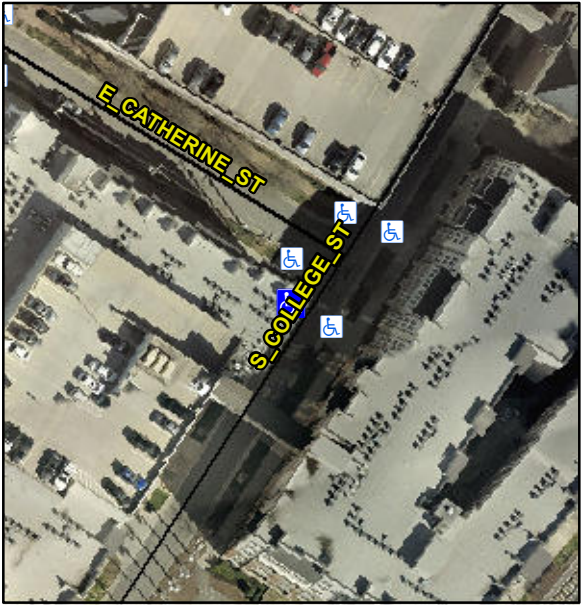
Possible Solutions:		<b>Compliance</b>	<b>Description</b>	<b>Data</b>
	Remove & Replace Entire Ramp.		N/A	Ramp Length (in)	99.0
			Yes	Ramp Width (in)	48.0
			N/A	Flare Type LT	N/A
			N/A	Flare Slope LT (%)	N/A
			N/A	Flare Traversable LT?	N/A
			N/A	Landing Length (in)	N/A
			N/A	Landing Width (in)	N/A
			N/A	Landing Slope (%)	N/A
			N/A	Landing X Slope (%)	N/A
<p>Surveyor Notes:</p> <p>N/A</p> <p>PROW/ADA:</p> <p>Not Found, R304.2.2, R304.5.3</p>			N/A	Flare Type RT	N/A
			N/A	Flare Slope RT (%)	N/A
			N/A	Flare Traversable RT?	N/A
			N/A	DWS Provided?	N/A
			N/A	DWS Contrast?	N/A
			N/A	DWS Length (in)	N/A
			N/A	DWS Full Width?	N/A
			N/A	DWS Offset (in)	N/A
			N/A	Gutter Ponding?	N/A
			N/A	Gutter Lip Ht (in)	N/A
<p>Total Cost:</p> <p>\$ 1850.00</p>			N/A	Painted X Walk1?	No
				X Walk 1 Direction	To SE
			N/A	X Walk 1 Width (in)	N/A

X Walk 1 Slope (%)	2.3
				X Walk 1 X Slope (%)	4.8
			N/A	Ramp inside XWalk1?	N/A
				Road Slope (%)	N/A
				Road X Slope (%)	N/A
			N/A	Any Obstructions?	N/A
				Obstruction Type	
			N/A	Clear Space?	N/A
				Clear Space to XWalk (in)	N/A
			N/A	Storm Grate/Utility Hazard?	N/A
				Storm Grate/Utility Type	
			N/A		N/A
			Yes	Surface Condition? (G/P)	Good
