# Access Compliance Report

## Public Rights-of-Way

### (Curb Ramps)

| Intersection ID: 20410 | Main Street: CARMEL_RD | Cross Street: FAIRVIEW_RD | Location: E |

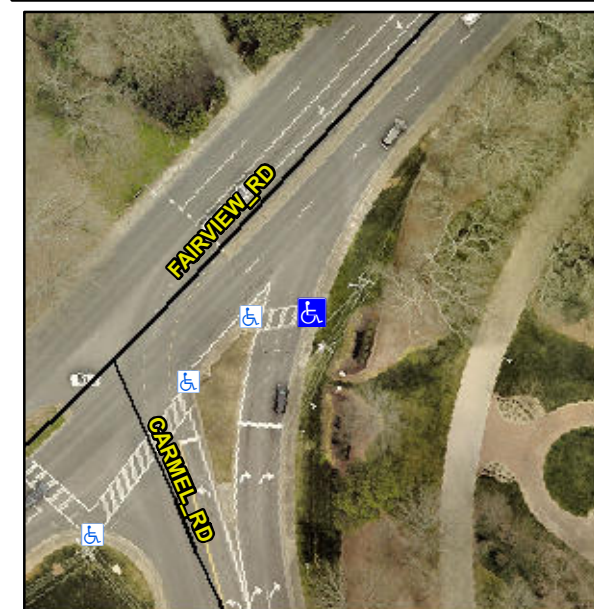
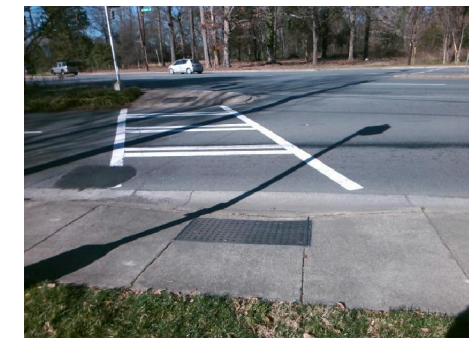
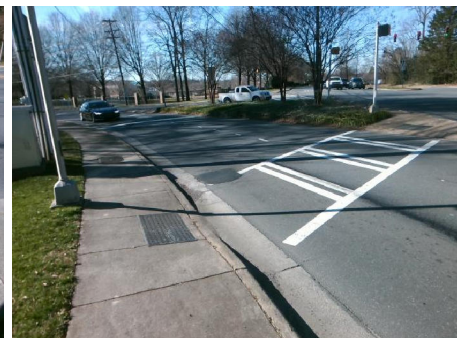
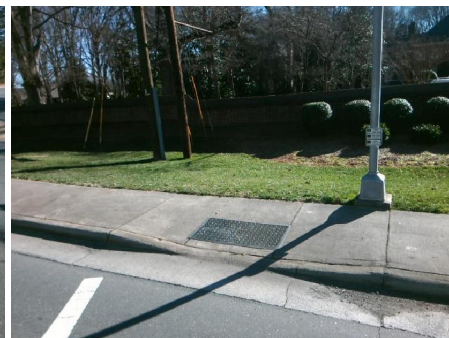
| ADA ID: 0AA49B46F56A | Ramp Type: Perp | Initial Pass/Fail: Fail | Overall Compliance: No |
| Severity Score: 22.5 | | | |

**Not Found, R304.5.1, R304.2.2, R304.5.3**

| Compliance | Description | Data | Compliance | Description | Data |
|---|---|---|---|---|---|
| N/A | Ramp Length (in) | 60.0 | No | Ramp Slope (%) | 11.8 |
| No | Ramp Width (in) | 45.5 | No | Ramp XSlope (%) | 2.9 |

**Remove & Replace Entire Ramp.**
