Access Compliance Report

Public Rights-of-Way

(Curb Ramps)

Intersection ID: 16746	Main Street: PRINCETON_AV	Cross Street: STERLING_RD	Location: SE
ADA ID: 0AB86D746287	Ramp Type: PerpDiag	Initial Pass/Fail: Fail	Overall Compliance: No
		Severity Score: 22.5

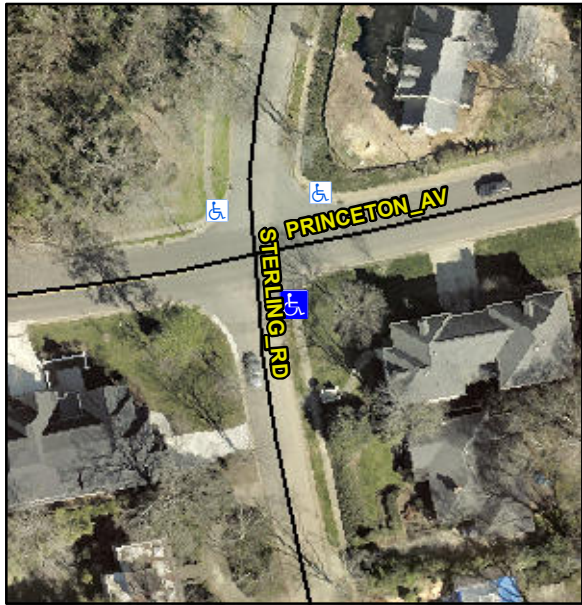
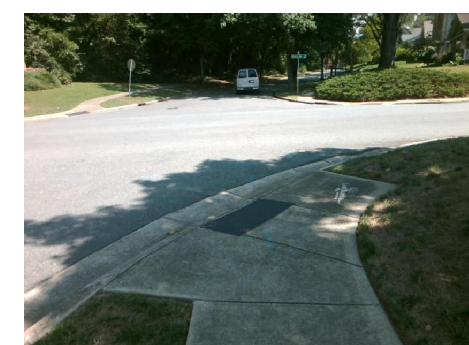
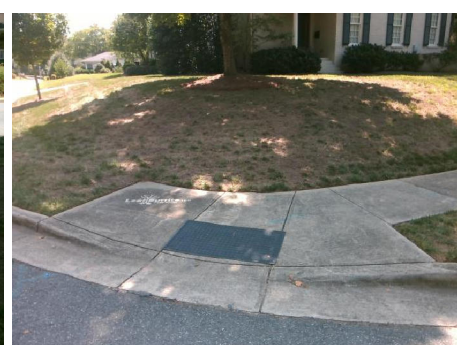
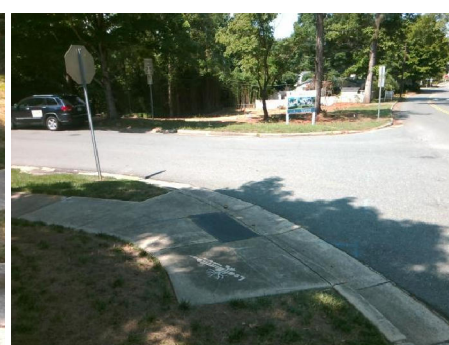
Possible Solutions:			Compliance	Description	Data	Compliance	Description	Data
	Remove & Replace Curb Ramp With Two New Directional Ramps or Equivalent.	N/A	Ramp Length (in)	65.0	No	Ramp Slope (%)	10.2		
		No	Ramp Width (in)	41.0	No	Ramp XSlope (%)	4.9		
		N/A	Flare Type LT	N/A	N/A	Flare Type RT	N/A		
	N/A	Flare Slope LT (%)	N/A	N/A	Flare Slope RT (%)	N/A			
	N/A	Flare Traversable LT?	N/A	N/A	Flare Traversable RT?	N/A			
	N/A	Landing Length (in)	N/A	N/A	DWS Provided?	N/A			
	N/A	Landing Width (in)	N/A	N/A	DWS Contrast?	N/A			
	N/A	Landing Slope (%)	N/A	N/A	DWS Length (in)	N/A			
	N/A	Landing X Slope (%)	N/A	N/A	DWS Full Width?	N/A			
N/A	Landing Curb? (Y/N)	N/A	N/A	DWS Offset (in)	N/A				
Surveyor Notes:	N/A	N/A	Shared Landing?	N/A					
		N/A	Gutter Ponding?	N/A	N/A	Gutter Slope (%)	N/A		
		N/A	Gutter Lip Ht (in)	N/A	N/A	Gutter X Slope (%)	N/A

PROW/ADA:	N/A	Painted X Walk1?	No	N/A	Painted X Walk2?	No		
			X Walk 1 Direction	To NE		X Walk 2 Direction	To W		
		N/A	X Walk 1 Width (in)	N/A	N/A	X Walk 2 Width (in)	N/A		
			X Walk 1 Slope (%)	6.5		X Walk 2 Slope (%)	1.2		
			X Walk 1 X Slope (%)	1.2		X Walk 2 X Slope (%)	3.1		
		N/A	Ramp inside XWalk1?	N/A	N/A	Ramp inside XWalk2?	N/A		
			Road Slope (%)	4.3	N/A	Clear Space?	N/A		
	Road X Slope (%)	2.2	N/A	Clear Space to XWalk (in)	N/A				
Total Cost:	\$ 3200.00	N/A	Any Obstructions?	N/A	N/A	Storm Grate/Utility Hazard?	N/A		
			Obstruction Type			Storm Grate/Utility Type			
				N/A			N/A		
			Yes	Surface Condition? (G/P)	Good
