# Access Compliance Report

## Public Rights-of-Way

### (Curb Ramps)

Intersection ID: 28768	Main Street: FOUNTAINGROVE_DR	Cross Street: MAYCROFT_DR	Location:	N
ADA ID: 0ABBA838A843	Ramp Type: Perp	Initial Pass/Fail: Fail	Overall Compliance: No	Severity Score: 42.5
Codes/Mitigation Info/Possible Solution		Field Measurements/Component Compliance

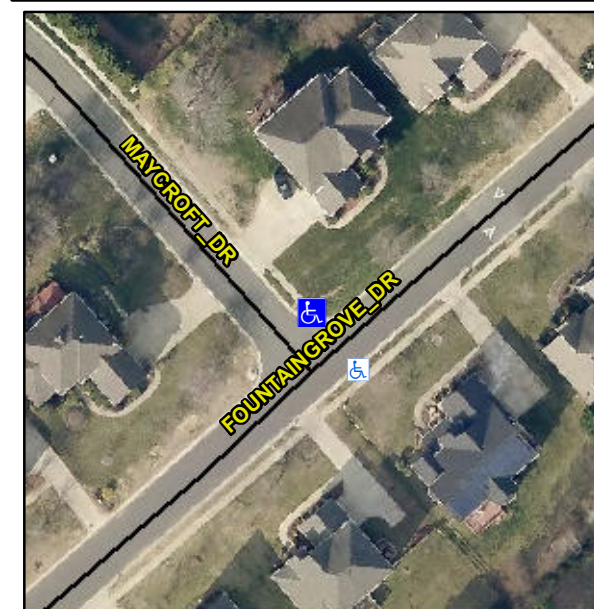
Compliance	Description	Data	Compliance	Description	Data
N/A	Ramp Length (in)	32.0	No	Ramp Slope (%)	9.7
No	Ramp Width (in)	34.0	No	Ramp XSlope (%)	6.5
N/A	Flare Type LT	N/A	N/A	Flare Type RT	N/A
N/A	Flare Slope LT (%)	N/A	N/A	Flare Slope RT (%)	N/A
N/A	Flare Traversable LT?	N/A	N/A	Flare Traversable RT?	N/A
N/A	Landing Length (in)	N/A	N/A	DWS Provided?	N/A
N/A	Landing Width (in)	N/A	N/A	DWS Contrast?	N/A
N/A	Landing Slope (%)	N/A	N/A	DWS Length (in)	N/A
N/A	Landing X Slope (%)	N/A	N/A	DWS Full Width?	N/A
N/A	Landing Curb? (Y/N)	N/A	N/A	DWS Offset (in)	N/A
N/A	Shared Landing?	N/A			
N/A	Gutter Ponding?	N/A	N/A	Gutter Slope (%)	N/A
N/A	Gutter Lip Ht (in)	N/A	N/A	Gutter X Slope (%)	N/A
N/A	Painted X Walk1?	No	N/A	Painted X Walk2?	N/A
	X Walk 1 Direction	To SE		X Walk 2 Direction	N/A
N/A	X Walk 1 Width (in)	N/A	N/A	X Walk 2 Width (in)	N/A
	X Walk 1 Slope (%)	3.2		X Walk 2 Slope (%)	N/A
	X Walk 1 X Slope (%)	2.6		X Walk 2 X Slope (%)	N/A

N/A	Ramp inside XWalk1?	N/A	N/A	Ramp inside XWalk2?	N/A
	Road Slope (%)	N/A	N/A	Clear Space?	N/A
	Road X Slope (%)	N/A	N/A	Clear Space to XWalk (in)	N/A
N/A	Any Obstructions?	N/A	N/A	Storm Grate/Utility Hazard?	N/A
	Obstruction Type			Storm Grate/Utility Type	
		N/A			N/A
			Yes	Surface Condition? (G/P)	Good

**Remove & Replace Entire Ramp.**

**R304.5.1, R304.2.2, R304.5.3**

Total Cost: \$ 1850.00
