Access Compliance Report

Public Rights-of-Way

(Curb Ramps)

Intersection ID: 25333	Main Street: CARMEL_RD	Cross Street: MEADOWRIDGE_DR	Location: W
ADA ID: 0AC05F167488	Ramp Type: PerpDiag	Initial Pass/Fail: Fail	Overall Compliance: No
Severity Score: 46.25			
Codes/Mitigation Info/Possible Solution		Field Measurements/Component Compliance

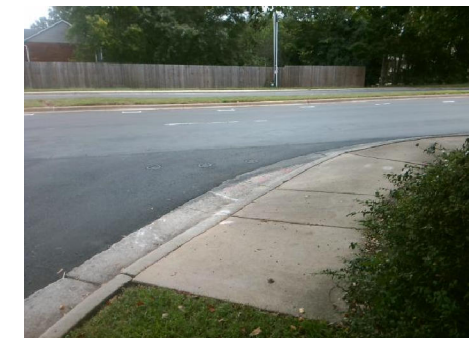
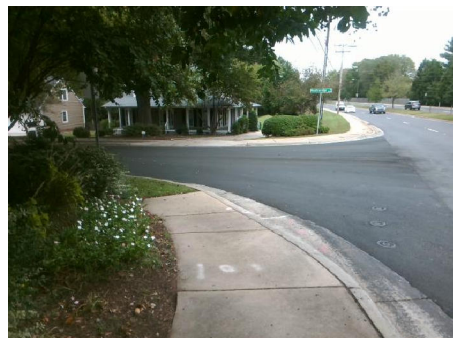
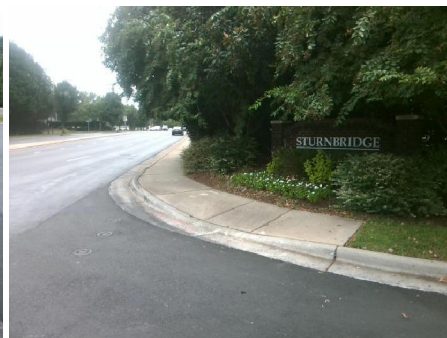
Compliance	Description	Data	Compliance	Description	Data
N/A	Ramp Length (in)	60.0	No	Ramp Slope (%)	14.1
No	Ramp Width (in)	37.0	No	Ramp XSlope (%)	5.8
N/A	Flare Type LT	N/A	N/A	Flare Type RT	N/A
N/A	Flare Slope LT (%)	N/A	N/A	Flare Slope RT (%)	N/A
N/A	Flare Traversable LT?	N/A	N/A	Flare Traversable RT?	N/A
N/A	Landing Length (in)	N/A	N/A	DWS Provided?	N/A
N/A	Landing Width (in)	N/A	N/A	DWS Contrast?	N/A
N/A	Landing Slope (%)	N/A	N/A	DWS Length (in)	N/A
N/A	Landing X Slope (%)	N/A	N/A	DWS Full Width?	N/A
N/A	Landing Curb? (Y/N)	N/A	N/A	DWS Offset (in)	N/A
N/A	Shared Landing?	N/A			
N/A	Gutter Ponding?	N/A	N/A	Gutter Slope (%)	N/A
N/A	Gutter Lip Ht (in)	N/A	N/A	Gutter X Slope (%)	N/A
N/A	Painted X Walk1?	No	N/A	Painted X Walk2?	No
	X Walk 1 Direction	To SE		X Walk 2 Direction	To NE
N/A	X Walk 1 Width (in)	N/A	N/A	X Walk 2 Width (in)	N/A
	X Walk 1 Slope (%)	1.0		X Walk 2 Slope (%)	1.6
	X Walk 1 X Slope (%)	0.7		X Walk 2 X Slope (%)	3.5

N/A	Ramp inside XWalk1?	N/A	N/A	Ramp inside XWalk2?	N/A
	Road Slope (%)	0.8	N/A	Clear Space?	N/A
	Road X Slope (%)	3.7	N/A	Clear Space to XWalk (in)	N/A
N/A	Any Obstructions?	N/A	N/A	Storm Grate/Utility Hazard?	N/A
	Obstruction Type			Storm Grate/Utility Type	
		N/A			N/A
			Yes	Surface Condition? (G/P)	Good

Remove & Replace Curb Ramp With Two New Directional Ramps or Equivalent.
