Access Compliance Report Public Rights-of-Way (Curb Ramps)

Intersection ID: 49384 Main Street: SOUTH DEVON ST **Cross Street: SHORTHORN_ST** Location: ADA ID: 0AD6D9D993FD Ramp Type: PerpDiag Initial Pass/Fail: Fail **Overall Compliance: No Severity Score:** 12.5

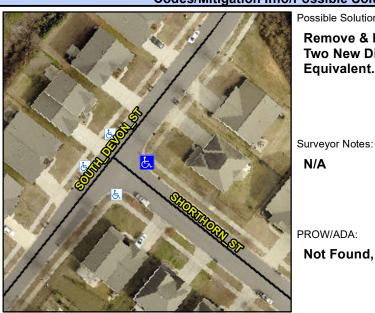
Field Measurements/Component Compliance					
Compliance Description		Data	Com	oliance Description	Data
N	A Ramp Length (in)	71.0	Yes	Ramp Slope (%)	6.2
Ye	s Ramp Width (in)	48.0	No	Ramp XSlope (%)	5.3
N/	A Flare Type LT	N/A	N/A	Flare Type RT	N/A
N	A Flare Slope LT (%)	N/A	N/A	Flare Slope RT (%)	N/A
N	A Flare Traversable LT?	N/A	N/A	Flare Traversable RT?	N/A
N	A Landing Length (in)	N/A	N/A	DWS Provided?	N/A
N	A Landing Width (in)	N/A	N/A	DWS Contrast?	N/A
N	A Landing Slope (%)	N/A	N/A	DWS Length (in)	N/A
N	A Landing X Slope (%)	N/A	N/A	DWS Full Width?	N/A
N	A Landing Curb? (Y/N)	N/A	N/A	DWS Offset (in)	N/A
N	A Shared Landing?	N/A			
N	A Gutter Ponding?	N/A	N/A	Gutter Slope (%)	N/A
N/	A Gutter Lip Ht (in)	1.0	N/A	Gutter X Slope (%)	N/A
N	A Painted X Walk1?	No	N/A	Painted X Walk2?	No
	X Walk 1 Direction	To NW		X Walk 2 Direction	To SW
N	A X Walk 1 Width (in)	N/A	N/A	X Walk 2 Width (in)	N/A
	X Walk 1 Slope (%)	1.1		X Walk 2 Slope (%)	0.6

X Walk 1 X Slope (%)	2.8		X Walk 2 X Slope (%)	3.8
N	A Ramp inside XWalk1?	N/A	N/A	Ramp inside XWalk2?	N/A
	Road Slope (%)	5.2	N/A	Clear Space?	N/A
	Road X Slope (%)	2.9	N/A	Clear Space to XWalk (in)	N/A
N	A Any Obstructions?	N/A	N/A	Storm Grate/Utility Hazard?	N/A
	Obstruction Type			Storm Grate/Utility Type	
		N/A			N/A
			Yes	Surface Condition? (G/P)	Good
200	A MARINE TO THE PARTY OF THE PA

Street 1 Name Stop Condition-Street 2 Street 2 Name Stop Condition-Street 1 **SOUTH DEVON ST** None **SHORTHORN ST** StopSign Possible Solutions: Remove & Replace Curb Ramp With **Two New Directional Ramps or** Equivalent.

Not Found, R304.5.3

Total Cost: 3200.00
