Access Compliance Report Public Rights-of-Way (Curb Ramps)

Intersection ID: N/A Main Street: MEADOW VISTA RD Cross Street: OLD CONCORD RD Location: SW ADA ID: 0AD8428462B3 Ramp Type: PerpDiag Initial Pass/Fail: Fail **Overall Compliance: No Severity Score:** 8.75

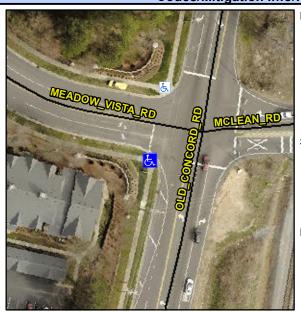
Compliance Description Data Compliance Description Data					
N/A Ramp Length (in)		60.0	Yes	Ramp Slope (%)	5.2
No.	Ramp Width (in)	41.0	Yes	Ramp XSlope (%)	0.9
N/A	Flare Type LT	N/A	N/A	Flare Type RT	N/A
N/A	Flare Slope LT (%)	N/A	N/A	Flare Slope RT (%)	N/A
N/A N/A	Flare Traversable LT?	N/A	N/A N/A	Flare Traversable RT?	N/A
N/A N/A		N/A N/A	N/A N/A	DWS Provided?	N/A N/A
	Landing Length (in)				
N/A	Landing Width (in)	N/A	N/A	DWS Contrast?	N/A
N/A	Landing Slope (%)	N/A	N/A	DWS Length (in)	N/A
N/A	Landing X Slope (%)	N/A	N/A	DWS Full Width?	N/A
N/A	Landing Curb? (Y/N)	N/A	N/A	DWS Offset (in)	N/A
N/A	Shared Landing?	N/A			
N/A	Gutter Ponding?	N/A	N/A	Gutter Slope (%)	N/A
N/A	Gutter Lip Ht (in)	N/A	N/A	Gutter X Slope (%)	N/A
N/A	Painted X Walk1?	No	N/A	Painted X Walk2?	No
	X Walk 1 Direction	To E		X Walk 2 Direction	To N
N/A	X Walk 1 Width (in)	N/A	N/A	X Walk 2 Width (in)	N/A
	X Walk 1 Slope (%)	5.8		X Walk 2 Slope (%)	2.8

X Walk 1 X Slope (%)	1.1		X Walk 2 X Slope (%)	1.4
N/A	Ramp inside XWalk1?	N/A	N/A	Ramp inside XWalk2?	N/A
	Road Slope (%)	1.5	N/A	Clear Space?	N/A
	Road X Slope (%)	4.2	N/A	Clear Space to XWalk (in)	N/A
N/A	Any Obstructions?	N/A	N/A	Storm Grate/Utility Hazard?	N/A
	Obstruction Type			Storm Grate/Utility Type	
		N/A			N/A
			Yes	Surface Condition? (G/P)	Good
The Pedrone

Possible Solutions: **Remove & Replace Curb Ramp With Two New Directional Ramps or** Equivalent. Surveyor Notes: N/A

PROW/ADA: R304.5.1 Total Cost:
