# Access Compliance Report

## Public Rights-of-Way

### (Curb Ramps)

| Intersection ID: 49553 | Main Street: STEEL_GARDENS_BV | Cross Street: WARREN_BURGESS_LN | Location: SW |

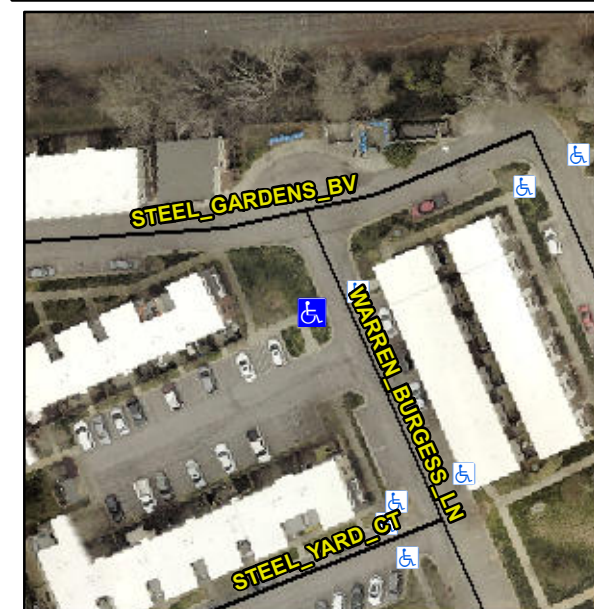
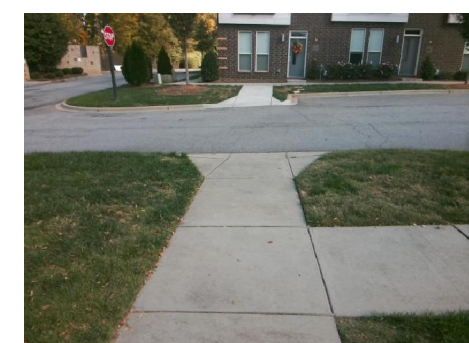
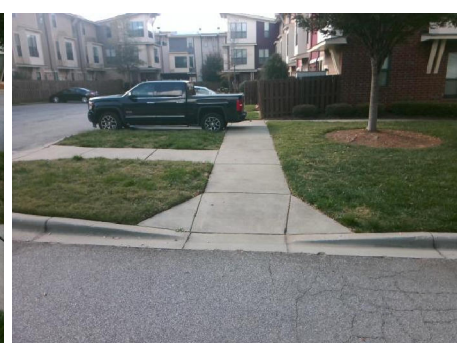
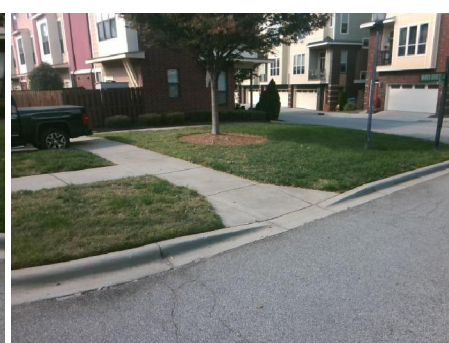
| ADA ID: 0AE148711D13 | Ramp Type: Perp | Initial Pass/Fail: Fail | Overall Compliance: No |

| Compliance | Description | Data | Compliance | Description | Data |
|---|---|---|---|---|---|
| Yes | Ramp Width (in) | 49.0 | No | Ramp XSlope (%) | 3.6 |

**Remove & Replace Entire Ramp.**

**R304.5.3**

**\$ 1850.00**
