# Access Compliance Report

## Public Rights-of-Way

### (Curb Ramps)

Intersection ID: 14386	Main Street: LILLINGTON_AV	Cross Street: LUTHER_ST	Location:	N
ADA ID: 0AE476606F49	Ramp Type: PerpDiag	Initial Pass/Fail: Fail	Overall Compliance: No	Severity Score: 35

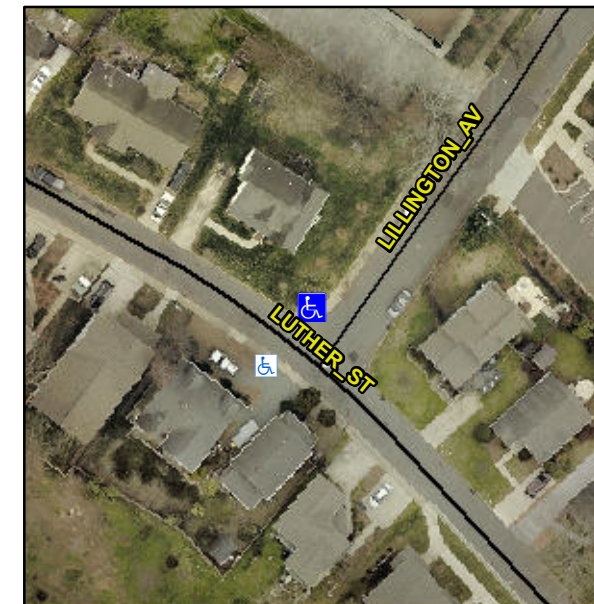
**R304.5.1, R304.2.2, R304.5.3**

Compliance	Description	Data	Compliance	Description	Data
N/A	Ramp Length (in)	63.0	No	Ramp Slope (%)	14.1
No	Ramp Width (in)	45.0	No	Ramp XSlope (%)	2.9
N/A	Flare Type LT	N/A	N/A	Flare Type RT	N/A
N/A	Flare Slope LT (%)	N/A	N/A	Flare Slope RT (%)	N/A
N/A	Flare Traversable LT?	N/A	N/A	Flare Traversable RT?	N/A
N/A	Landing Length (in)	N/A	N/A	DWS Provided?	N/A
N/A	Landing Width (in)	N/A	N/A	DWS Contrast?	N/A
N/A	Landing Slope (%)	N/A	N/A	DWS Length (in)	N/A
N/A	Landing X Slope (%)	N/A	N/A	DWS Full Width?	N/A
N/A	Landing Curb? (Y/N)	N/A	N/A	DWS Offset (in)	N/A
N/A	Shared Landing?	N/A			
N/A	Gutter Ponding?	N/A	N/A	Gutter Slope (%)	N/A
N/A	Gutter Lip Ht (in)	N/A	N/A	Gutter X Slope (%)	N/A
N/A	Painted X Walk1?	No	N/A	Painted X Walk2?	No
	X Walk 1 Direction	To SW		X Walk 2 Direction	To SE
N/A	X Walk 1 Width (in)	N/A	N/A	X Walk 2 Width (in)	N/A
	X Walk 1 Slope (%)	2.2		X Walk 2 Slope (%)	1.6
	X Walk 1 X Slope (%)	0.8		X Walk 2 X Slope (%)	3.5

N/A	Ramp inside XWalk1?	N/A	N/A	Ramp inside XWalk2?	N/A
	Road Slope (%)	1.9	N/A	Clear Space?	N/A
	Road X Slope (%)	0.5	N/A	Clear Space to XWalk (in)	N/A
N/A	Any Obstructions?	N/A	N/A	Storm Grate/Utility Hazard?	N/A
	Obstruction Type			Storm Grate/Utility Type	
		N/A			N/A
			Yes	Surface Condition? (G/P)	Good

**Remove & Replace Curb Ramp With Two New Directional Ramps or Equivalent.**

Total Cost: \$ 3200.00
