# Access Compliance Report

## Public Rights-of-Way

### (Curb Ramps)

Intersection ID: 48073	Main Street: MALLARD_HIGHLANDS_DR	Cross Street: MALLARD_GLEN_DR	Location: S
ADA ID: 0AE72E9F8DAD	Ramp Type: PerpDiag	Initial Pass/Fail: Fail	Overall Compliance: No
Severity Score: 46.25			
Codes/Mitigation Info/Possible Solution		Field Measurements/Component Compliance

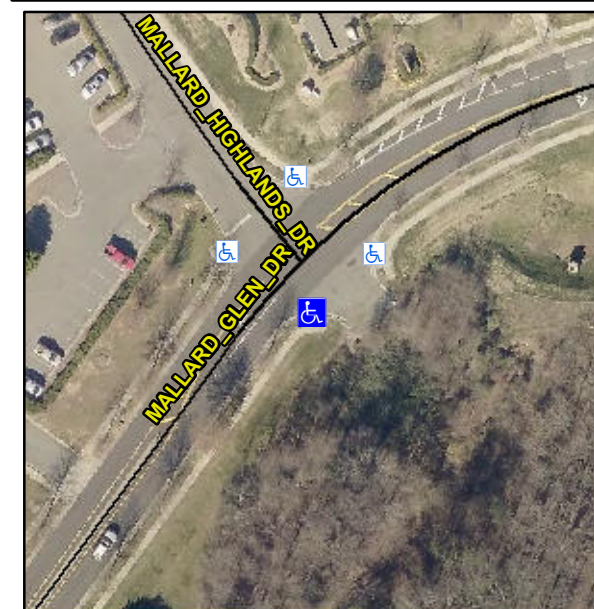
Compliance	Description	Data	Compliance	Description	Data
N/A	Ramp Length (in)	62.0	No	Ramp Slope (%)	11.0
No	Ramp Width (in)	41.0	No	Ramp XSlope (%)	7.6
N/A	Flare Type LT	N/A	N/A	Flare Type RT	N/A
N/A	Flare Slope LT (%)	N/A	N/A	Flare Slope RT (%)	N/A
N/A	Flare Traversable LT?	N/A	N/A	Flare Traversable RT?	N/A
N/A	Landing Length (in)	N/A	N/A	DWS Provided?	N/A
N/A	Landing Width (in)	N/A	N/A	DWS Contrast?	N/A
N/A	Landing Slope (%)	N/A	N/A	DWS Length (in)	N/A
N/A	Landing X Slope (%)	N/A	N/A	DWS Full Width?	N/A
N/A	Landing Curb? (Y/N)	N/A	N/A	DWS Offset (in)	N/A
N/A	Shared Landing?	N/A			
N/A	Gutter Ponding?	N/A	N/A	Gutter Slope (%)	N/A
N/A	Gutter Lip Ht (in)	N/A	N/A	Gutter X Slope (%)	N/A
N/A	Painted X Walk1?	No	N/A	Painted X Walk2?	No
	X Walk 1 Direction	To NE		X Walk 2 Direction	To NW
N/A	X Walk 1 Width (in)	N/A	N/A	X Walk 2 Width (in)	N/A
	X Walk 1 Slope (%)	3.8		X Walk 2 Slope (%)	6.0
	X Walk 1 X Slope (%)	5.1		X Walk 2 X Slope (%)	0.4

N/A	Ramp inside XWalk1?	N/A	N/A	Ramp inside XWalk2?	N/A
	Road Slope (%)	4.8	N/A	Clear Space?	N/A
	Road X Slope (%)	1.3	N/A	Clear Space to XWalk (in)	N/A
N/A	Any Obstructions?	N/A	N/A	Storm Grate/Utility Hazard?	N/A
	Obstruction Type			Storm Grate/Utility Type	
		N/A			N/A
			Yes	Surface Condition? (G/P)	Good

Possible Solutions:

**Remove & Replace Curb Ramp With Two New Directional Ramps or Equivalent.**

**R304.5.1, R304.2.2, R304.5.3**
