## Access Compliance Report Public Rights-of-Way (Curb Ramps)

Intersection ID: N/AMain Street: STEELE\_CREEK\_RDCross Street: N/ALocation:SEADA ID: 0AEC92DD75A7Ramp Type: PerpInitial Pass/Fail: FailOverall Compliance: NoSeverity Score: 12.5

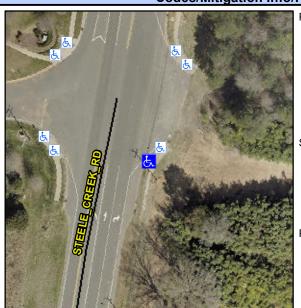
Comp	liance Description	Data	Comp	liance	Description	Data
N/A	Ramp Length (in)	60.0	No	Ram	Slope (%)	10.0
Yes	Ramp Width (in)	60.0	Yes	Ram	XSlope (%)	1.9
N/A	Flare Type LT	N/A	N/A	Flare	Type RT	N/A
N/A	Flare Slope LT (%)	N/A	N/A	Flare	Slope RT (%)	N/A
N/A	Flare Traversable LT?	N/A	N/A	Flare	Traversable RT?	N/A
N/A	Landing Length (in)	N/A	N/A	DWS	Provided?	N/A
N/A	Landing Width (in)	N/A	N/A	DWS	Contrast?	N/A
N/A	Landing Slope (%)	N/A	N/A	DWS	Length (in)	N/A
N/A	Landing X Slope (%)	N/A	N/A	DWS	Full Width?	N/A
N/A	Landing Curb? (Y/N)	N/A	N/A	DWS	Offset (in)	N/A
N/A	Shared Landing?	N/A				
N/A	Gutter Ponding?	N/A	N/A	Gutte	er Slope (%)	N/A
N/A	Gutter Lip Ht (in)	N/A	N/A	Gutte	er X Slope (%)	N/A
N/A	Painted X Walk1?	No	N/A	Paint	ed X Walk2?	N/A
	X Walk 1 Direction	To NW		X Wa	lk 2 Direction	N/A
N/A	X Walk 1 Width (in)	N/A	N/A	X Wa	lk 2 Width (in)	N/A
	X Walk 1 Slope (%)	1.0		X Wa	lk 2 Slope (%)	N/A
	X Walk 1 X Slope (%)	1.0		X Wa	lk 2 X Slope (%)	N/A

N/A	Ramp inside XWalk1?	N/A	N/A	Ram	o inside XWalk2?	N/A
	Road Slope (%)	N/A	N/A	Clear	Space?	N/A
	Road X Slope (%)	N/A	N/A	Clear	Space to XWalk (in)	N/A
N/A	Any Obstructions?	N/A	N/A	Storn	n Grate/Utility Hazard?	N/A
	Obstruction Type			Storn	n Grate/Utility Type	
		N/A				N/A
			Yes	Surfa	ce Condition? (G/P)	Good

Remove & Replace Entire Ramp.

R304.2.2
