# Access Compliance Report

## Public Rights-of-Way

### (Curb Ramps)

Intersection ID: 13475	Main Street: KENHILL_DR	Cross Street: MARKLAND_DR	Location: NW
ADA ID: 0AF31DAACAAB	Ramp Type: PerpDiag	Initial Pass/Fail: Fail	Overall Compliance: No
		Severity Score: 37.5

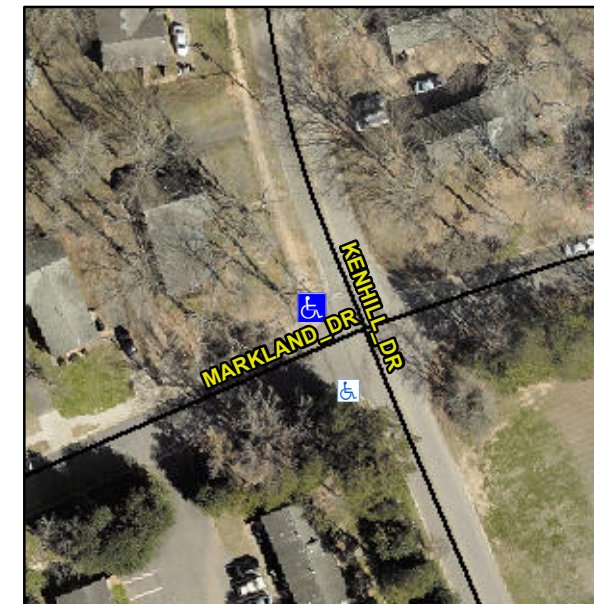
**Not Found, R304.2.2, R304.5.3**

Compliance	Description	Data	Compliance	Description	Data
N/A	Ramp Length (in)	82.0	No	Ramp Slope (%)	8.7
Yes	Ramp Width (in)	48.0	No	Ramp XSlope (%)	8.2
N/A	Flare Type LT	N/A	N/A	Flare Type RT	N/A
N/A	Flare Slope LT (%)	N/A	N/A	Flare Slope RT (%)	N/A
N/A	Flare Traversable LT?	N/A	N/A	Flare Traversable RT?	N/A
N/A	Landing Length (in)	N/A	N/A	DWS Provided?	N/A
N/A	Landing Width (in)	N/A	N/A	DWS Contrast?	N/A
N/A	Landing Slope (%)	N/A	N/A	DWS Length (in)	N/A
N/A	Landing X Slope (%)	N/A	N/A	DWS Full Width?	N/A
N/A	Landing Curb? (Y/N)	N/A	N/A	DWS Offset (in)	N/A
N/A	Shared Landing?	N/A			
N/A	Gutter Ponding?	N/A	N/A	Gutter Slope (%)	N/A
N/A	Gutter Lip Ht (in)	N/A	N/A	Gutter X Slope (%)	N/A
N/A	Painted X Walk1?	No	N/A	Painted X Walk2?	No
	X Walk 1 Direction	To S		X Walk 2 Direction	To E
N/A	X Walk 1 Width (in)	N/A	N/A	X Walk 2 Width (in)	N/A
	X Walk 1 Slope (%)	1.7		X Walk 2 Slope (%)	3.6
	X Walk 1 X Slope (%)	2.9		X Walk 2 X Slope (%)	3.3

N/A	Ramp inside XWalk1?	N/A	N/A	Ramp inside XWalk2?	N/A
	Road Slope (%)	5.0	N/A	Clear Space?	N/A
	Road X Slope (%)	2.2	N/A	Clear Space to XWalk (in)	N/A
N/A	Any Obstructions?	N/A	N/A	Storm Grate/Utility Hazard?	N/A
	Obstruction Type			Storm Grate/Utility Type	
		N/A			N/A
			Yes	Surface Condition? (G/P)	Good

**Remove & Replace Curb Ramp With Two New Directional Ramps or Equivalent.**

Total Cost: \$ 3200.00
