# Access Compliance Report

## Public Rights-of-Way

| Intersection ID: 10033986 | Main Street: PARK_RD | Cross Street: N/A | Location: SE |
| ADA ID: 0AF59FE7FA23 | Ramp Type: PerpDiag | Initial Pass/Fail: Fail | Overall Compliance: No |

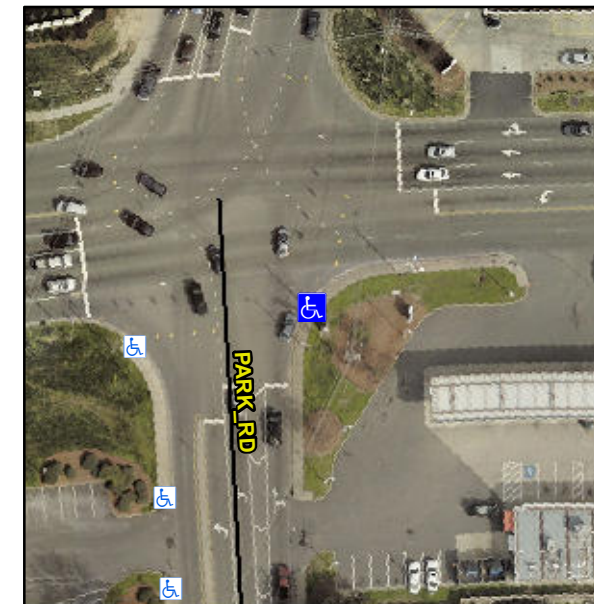
| | | Severity Score: 22.5 | |

**Not Found, R304.5.1, R304.2.2, R304.5.3**

| Compliance | Description | Data | Compliance | Description | Data |
|---|---|---|---|---|---|
| N/A | Ramp Length (in) | 62.0 | No | Ramp Slope (%) | 10.6 |
| No | Ramp Width (in) | 36.0 | No | Ramp XSlope (%) | 3.5 |

**Remove & Replace Curb Ramp With Two New Directional Ramps or Equivalent.**

Total Cost: \$ 3200.00

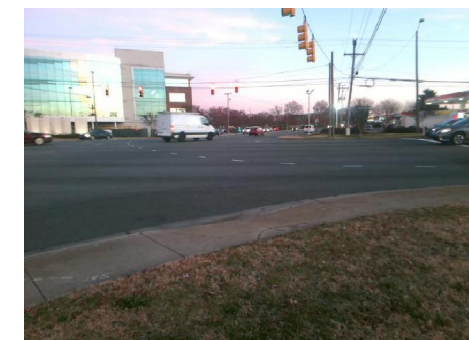
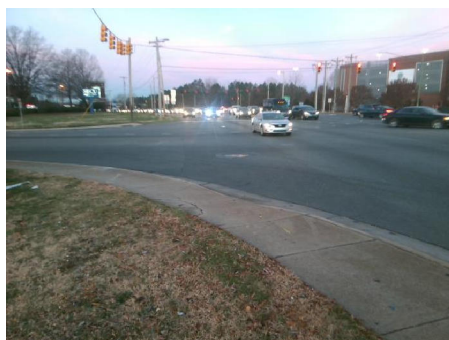
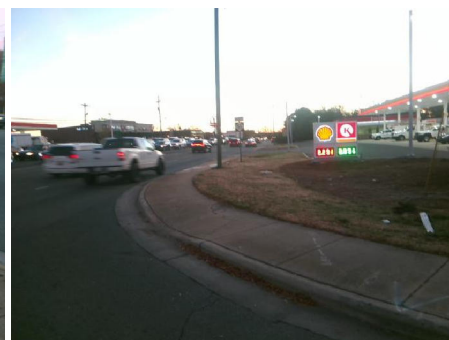
Street 1 Name PINEVILLE-MATTHEWS RD  
 Stop Condition-Street 2 Signal  
 Street 2 Name PARK RD  
 Stop Condition-Street 1 Signal
