## **Access Compliance Report Public Rights-of-Way** (Curb Ramps)

Intersection ID: 52487 Main Street: WHITEHALL\_EXECUTIVE\_CENTERs SDStreet: ORLICK\_DR Location: S

ADA ID: 0AFBD9825EC8 Ramp Type: Perp Initial Pass/Fail: Fail **Overall Compliance: No Severity Score:** 12.5

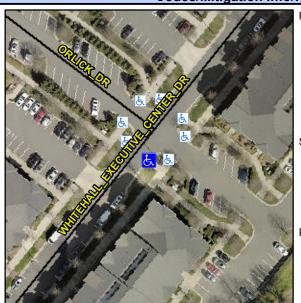
/Possible Solution		Field Measurements/Component Compliance					
Possible Solutions:		Comp	liance Description	Data	Compli	ance Description	Data
Remove & Replace Entire Ramp.		N/A	Ramp Length (in)	69.5	No	Ramp Slope (%)	9.3

•	Yes	Ramp Width (in)	67.0	Yes	Ramp XSlope (%)	0.9
		N/A	Flare Type LT	N/A	N/A	Flare Type RT	N/A
		N/A	Flare Slope LT (%)	N/A	N/A	Flare Slope RT (%)	N/A
		N/A	Flare Traversable LT?	N/A	N/A	Flare Traversable RT?	N/A
		N/A	Landing Length (in)	N/A	N/A	DWS Provided?	N/A
Surveyor Notes:		N/A	Landing Width (in)	N/A	N/A	DWS Contrast?	N/A
N/A		N/A	Landing Slope (%)	N/A	N/A	DWS Length (in)	N/A
É		N/A	Landing X Slope (%)	N/A	N/A	DWS Full Width?	N/A
		N/A	Landing Curb? (Y/N)	N/A	N/A	DWS Offset (in)	N/A
		N/A	Shared Landing?	N/A			
PROW/ADA:		N/A	Gutter Ponding?	N/A	N/A	Gutter Slope (%)	N/A
Not Found, R304.2.2		N/A	Gutter Lip Ht (in)	N/A	N/A	Gutter X Slope (%)	N/A
·		N/A	Painted X Walk1?	No	N/A	Painted X Walk2?	N/A
			X Walk 1 Direction	To NW		X Walk 2 Direction	N/A
		N/A	X Walk 1 Width (in)	N/A	N/A	X Walk 2 Width (in)	N/A
			X Walk 1 Slope (%)	1.9		X Walk 2 Slope (%)	N/A
			X Walk 1 X Slope (%)	1.1		X Walk 2 X Slope (%)	N/A

N/A	Ramp inside XWalk1?	N/A	N/A	Ramp inside XWalk2?	N/A
			Road Slope (%)	N/A	N/A	Clear Space?	N/A
			Road X Slope (%)	N/A	N/A	Clear Space to XWalk (in)	N/A
		N/A	Any Obstructions?	N/A	N/A	Storm Grate/Utility Hazard?	N/A
Total Cost:	\$ 1850.00		Obstruction Type			Storm Grate/Utility Type	
				N/A			N/A
