Access Compliance Report

Public Rights-of-Way

(Curb Ramps)

Intersection ID: 15147	Main Street: QUEENS_RD	Cross Street: EDGEHILL_RD_SOUTH	Location: NW
ADA ID: 0B12634ADDAE	Ramp Type: PerpDiag	Initial Pass/Fail: Fail	Overall Compliance: No
Severity Score: 25			
Codes/Mitigation Info/Possible Solution		Field Measurements/Component Compliance

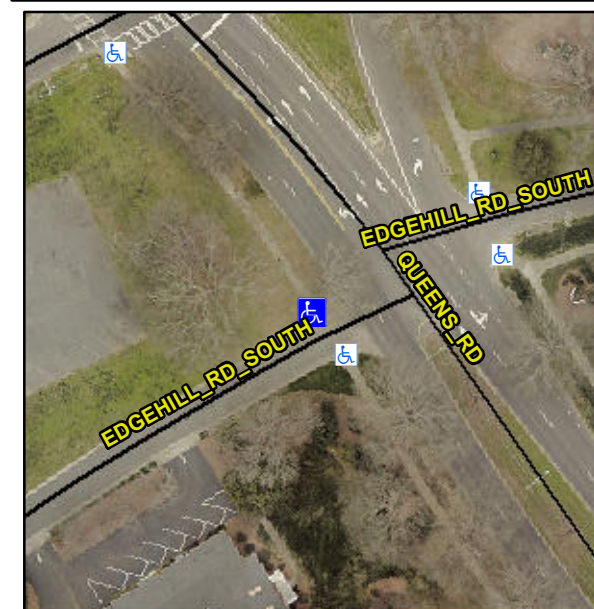
Compliance	Description	Data	Compliance	Description	Data
N/A	Ramp Length (in)	55.0	No	Ramp Slope (%)	15.4
Yes	Ramp Width (in)	60.0	Yes	Ramp XSlope (%)	1.1
N/A	Flare Type LT	N/A	N/A	Flare Type RT	N/A
N/A	Flare Slope LT (%)	N/A	N/A	Flare Slope RT (%)	N/A
N/A	Flare Traversable LT?	N/A	N/A	Flare Traversable RT?	N/A
N/A	Landing Length (in)	N/A	N/A	DWS Provided?	N/A
N/A	Landing Width (in)	N/A	N/A	DWS Contrast?	N/A
N/A	Landing Slope (%)	N/A	N/A	DWS Length (in)	N/A
N/A	Landing X Slope (%)	N/A	N/A	DWS Full Width?	N/A
N/A	Landing Curb? (Y/N)	N/A	N/A	DWS Offset (in)	N/A
N/A	Shared Landing?	N/A			
N/A	Gutter Ponding?	N/A	N/A	Gutter Slope (%)	N/A
N/A	Gutter Lip Ht (in)	N/A	N/A	Gutter X Slope (%)	N/A
N/A	Painted X Walk1?	No	N/A	Painted X Walk2?	No
	X Walk 1 Direction	To SE		X Walk 2 Direction	To NE
N/A	X Walk 1 Width (in)	N/A	N/A	X Walk 2 Width (in)	N/A
	X Walk 1 Slope (%)	1.3		X Walk 2 Slope (%)	0.3
	X Walk 1 X Slope (%)	0.2		X Walk 2 X Slope (%)	3.2

N/A	Ramp inside XWalk1?	N/A	N/A	Ramp inside XWalk2?	N/A
	Road Slope (%)	1.5	N/A	Clear Space?	N/A
	Road X Slope (%)	4.3	N/A	Clear Space to XWalk (in)	N/A
N/A	Any Obstructions?	N/A	N/A	Storm Grate/Utility Hazard?	N/A
	Obstruction Type			Storm Grate/Utility Type	
		N/A			N/A
		Yes		Surface Condition? (G/P)	Good

Possible Solutions:

Remove & Replace Curb Ramp With Two New Directional Ramps or Equivalent.

R304.2.2

Total Cost: \$ 3200.00
