Intersection ID: 12051	Main Street: LUMINA_AV	Cross Street: MARLOWE_AV	Location:	NE
ADA ID: 0B1B5913B9F6	Ramp Type: Perp	Initial Pass/Fail: Fail	Overall Compliance: No	Severity Score: 21.25

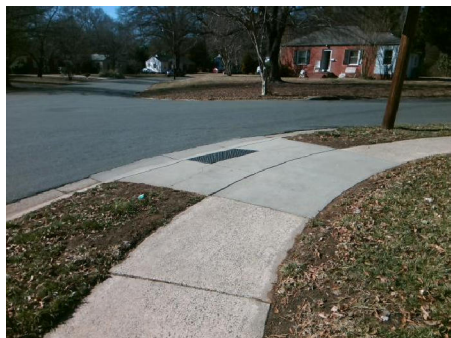
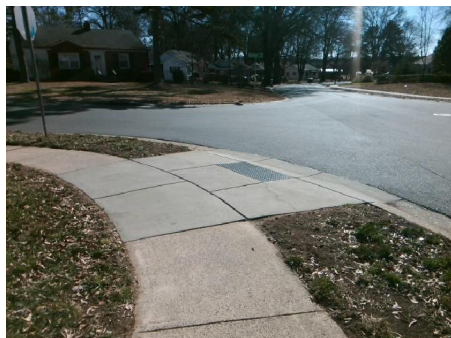
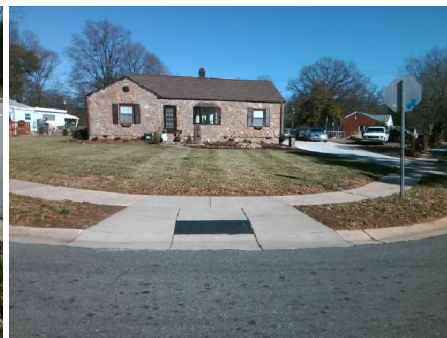
Not Found, R304.5.1, R304.2.2

Possible Solutions:			Compliance	Description	Data	Compliance	Description	Data		
Remove & Replace Entire Ramp.			N/A	Ramp Length (in)	60.0	No	Ramp Slope (%)	10.3		
			No	Ramp Width (in)	46.5	Yes	Ramp XSlope (%)	0.6		
			N/A	Flare Type LT	N/A	N/A	Flare Type RT	N/A		
			N/A	Flare Slope LT (%)	N/A	N/A	Flare Slope RT (%)	N/A		
			N/A	Flare Traversable LT?	N/A	N/A	Flare Traversable RT?	N/A		
			N/A	Landing Length (in)	N/A	N/A	DWS Provided?	N/A		
			N/A	Landing Width (in)	N/A	N/A	DWS Contrast?	N/A		
			N/A	Landing Slope (%)	N/A	N/A	DWS Length (in)	N/A		
			N/A	Landing X Slope (%)	N/A	N/A	DWS Full Width?	N/A		
			N/A	Landing Curb? (Y/N)	N/A	N/A	DWS Offset (in)	N/A		
Surveyor Notes: N/A			N/A	Shared Landing?	N/A					
			N/A	Gutter Ponding?	N/A	N/A	Gutter Slope (%)	N/A		
			N/A	Gutter Lip Ht (in)	N/A	N/A	Gutter X Slope (%)	N/A		
			N/A	Painted X Walk1?	No	N/A	Painted X Walk2?	N/A		
				X Walk 1 Direction	To SW		X Walk 2 Direction	N/A

N/A	X Walk 1 Width (in)	N/A	N/A	X Walk 2 Width (in)	N/A		
				X Walk 1 Slope (%)	1.4		X Walk 2 Slope (%)	N/A		
				X Walk 1 X Slope (%)	2.8		X Walk 2 X Slope (%)	N/A		
			N/A	Ramp inside XWalk1?	N/A	N/A	Ramp inside XWalk2?	N/A		
				Road Slope (%)	N/A	N/A	Clear Space?	N/A		
PROW/ADA: Not Found, R304.5.1, R304.2.2				Road X Slope (%)	N/A	N/A	Clear Space to XWalk (in)	N/A		
			N/A	Any Obstructions?	N/A	N/A	Storm Grate/Utility Hazard?	N/A		
				Obstruction Type			Storm Grate/Utility Type			
					N/A			N/A		
						Yes	Surface Condition? (G/P)	Good		
			Total Cost:			\$	1850.00

Remove & Replace Entire Ramp.
