Access Compliance Report

Public Rights-of-Way

(Curb Ramps)

Intersection ID: 5192	Main Street: CARRONBRIDGE_LN	Cross Street: SOUTHMINSTER_LN	Location: S
ADA ID: 0B26EF195C45	Ramp Type: Perp	Initial Pass/Fail: Fail	Overall Compliance: No
Severity Score: 12.5			
Codes/Mitigation Info/Possible Solution		Field Measurements/Component Compliance

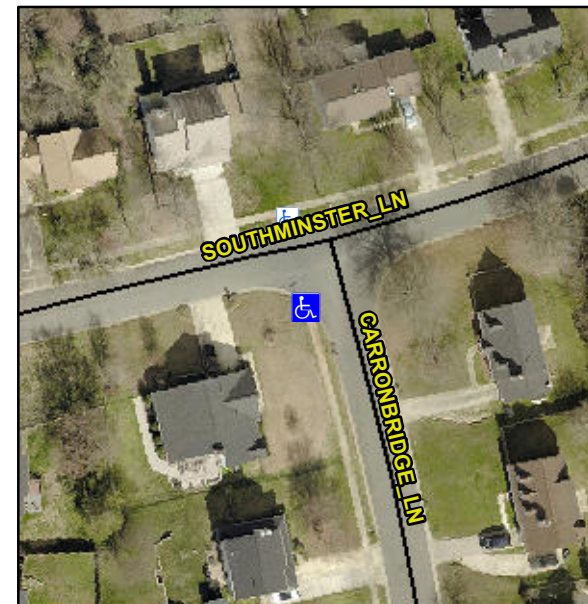
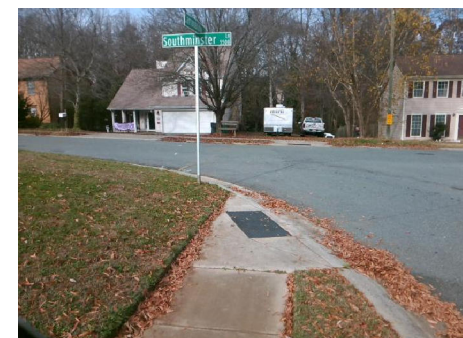
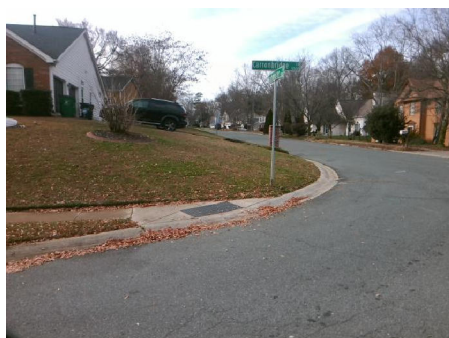
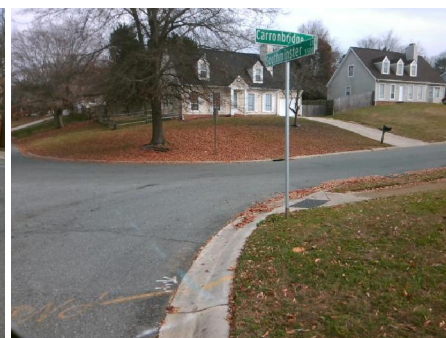
Not Found, R304.5.3

Compliance	Description	Data	Compliance	Description	Data
N/A	Ramp Length (in)	24.5	Yes	Ramp Slope (%)	6.6
Yes	Ramp Width (in)	48.0	No	Ramp XSlope (%)	5.2
N/A	Flare Type LT	N/A	N/A	Flare Type RT	N/A
N/A	Flare Slope LT (%)	N/A	N/A	Flare Slope RT (%)	N/A
N/A	Flare Traversable LT?	N/A	N/A	Flare Traversable RT?	N/A
N/A	Landing Length (in)	N/A	N/A	DWS Provided?	N/A
N/A	Landing Width (in)	N/A	N/A	DWS Contrast?	N/A
N/A	Landing Slope (%)	N/A	N/A	DWS Length (in)	N/A
N/A	Landing X Slope (%)	N/A	N/A	DWS Full Width?	N/A
N/A	Landing Curb? (Y/N)	N/A	N/A	DWS Offset (in)	N/A
N/A	Shared Landing?	N/A			
N/A	Gutter Ponding?	N/A	N/A	Gutter Slope (%)	N/A
N/A	Gutter Lip Ht (in)	N/A	N/A	Gutter X Slope (%)	N/A
N/A	Painted X Walk1?	No	N/A	Painted X Walk2?	N/A
	X Walk 1 Direction	To N		X Walk 2 Direction	N/A
N/A	X Walk 1 Width (in)	N/A	N/A	X Walk 2 Width (in)	N/A
	X Walk 1 Slope (%)	2.8		X Walk 2 Slope (%)	N/A
	X Walk 1 X Slope (%)	1.8		X Walk 2 X Slope (%)	N/A

N/A	Ramp inside XWalk1?	N/A	N/A	Ramp inside XWalk2?	N/A
	Road Slope (%)	N/A	N/A	Clear Space?	N/A
	Road X Slope (%)	N/A	N/A	Clear Space to XWalk (in)	N/A
N/A	Any Obstructions?	N/A	N/A	Storm Grate/Utility Hazard?	N/A
	Obstruction Type			Storm Grate/Utility Type	
		N/A			N/A
			Yes	Surface Condition? (G/P)	Good

Remove & Replace Entire Ramp.

Total Cost: \$ 1850.00
