Access Compliance Report

Public Rights-of-Way

(Curb Ramps)

Intersection ID: 27570	Main Street: ALTON_FARM_LN	Cross Street: DEER RIDGE_LN	Location: NE
ADA ID: 0B2D396568FE	Ramp Type: PerpDiag	Initial Pass/Fail: Fail	Overall Compliance: No
Codes/Mitigation Info/Possible Solution		Field Measurements/Component Compliance

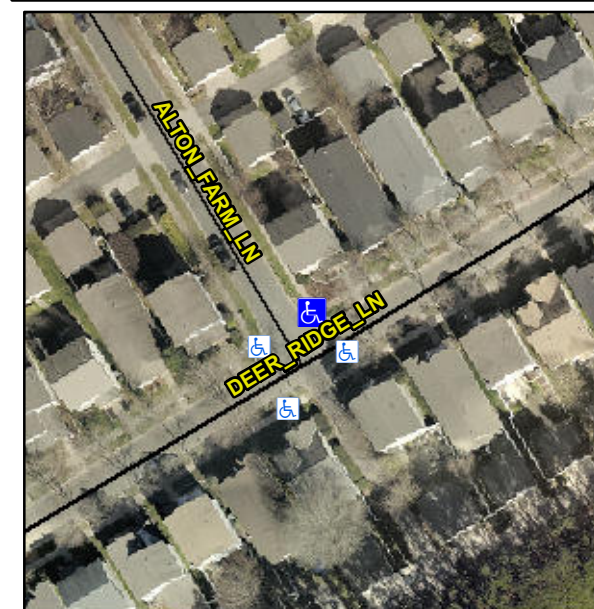
R304.2.2, R304.5.3

Compliance	Description	Data	Compliance	Description	Data
N/A	Ramp Length (in)	59.0	No	Ramp Slope (%)	9.1
Yes	Ramp Width (in)	48.0	No	Ramp XSlope (%)	2.9
N/A	Flare Type LT	N/A	N/A	Flare Type RT	N/A
N/A	Flare Slope LT (%)	N/A	N/A	Flare Slope RT (%)	N/A
N/A	Flare Traversable LT?	N/A	N/A	Flare Traversable RT?	N/A
N/A	Landing Length (in)	N/A	N/A	DWS Provided?	N/A
N/A	Landing Width (in)	N/A	N/A	DWS Contrast?	N/A
N/A	Landing Slope (%)	N/A	N/A	DWS Length (in)	N/A
N/A	Landing X Slope (%)	N/A	N/A	DWS Full Width?	N/A
N/A	Landing Curb? (Y/N)	N/A	N/A	DWS Offset (in)	N/A
N/A	Shared Landing?	N/A			
N/A	Gutter Ponding?	N/A	N/A	Gutter Slope (%)	N/A
N/A	Gutter Lip Ht (in)	N/A	N/A	Gutter X Slope (%)	N/A
N/A	Painted X Walk1?	No	N/A	Painted X Walk2?	No
	X Walk 1 Direction	To SW		X Walk 2 Direction	To SE
N/A	X Walk 1 Width (in)	N/A	N/A	X Walk 2 Width (in)	N/A
	X Walk 1 Slope (%)	1.4		X Walk 2 Slope (%)	1.1
	X Walk 1 X Slope (%)	3.3		X Walk 2 X Slope (%)	1.3

N/A	Ramp inside XWalk1?	N/A	N/A	Ramp inside XWalk2?	N/A
	Road Slope (%)	3.8	N/A	Clear Space?	N/A
	Road X Slope (%)	2.2	N/A	Clear Space to XWalk (in)	N/A
N/A	Any Obstructions?	N/A	N/A	Storm Grate/Utility Hazard?	N/A
	Obstruction Type			Storm Grate/Utility Type	
		N/A			N/A
			Yes	Surface Condition? (G/P)	Good

Remove & Replace Curb Ramp With Two New Directional Ramps or Equivalent.
