Access Compliance Report Public Rights-of-Way (Curb Ramps)

| Intersection ID: 10018468 | Main Street: POSSUM_TROT_LN | | | Cross Street: N/A | | | | Location: | S |
| ADA ID: 0B33AF76F001 | Ramp Type: Perp | | | Initial Pass/Fail: Fail Overall Compliance | | | nce: N | o Severity Score: | 8.75 |

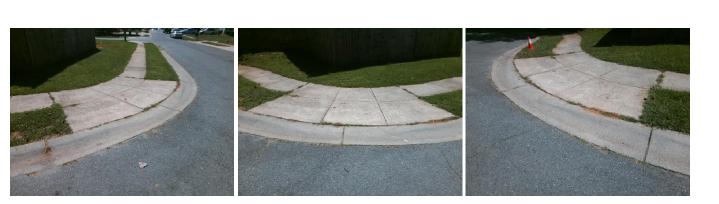
| Intersection ID: 10018468 | Main Street: POSSUM_TROT_LN | | | Cross Street: N/A | | | | Location: | S |
|---|---|---|---|--|---|---|---|---|---|
| | | Remove & Replace Entire Ra | mp. | N/A | Ramp Length (in) | 46.0 | Yes | Ramp Slope (%) | 6.9 |
| | | - | • | No | Ramp Width (in) | 45.5 | Yes | Ramp XSlope (%) | 2.0 |
| | A BAR | Not Found, R304.5.1 | | N/A | Gutter Lip Ht (in) | N/A | N/A | Gutter X Slope (%) | N/A |

Yes Surface Condition? (G/P)

Good

| Intersection ID: 10018468 | Main Street: POSSUM_TROT_LN | | | Cross Street: N/A | | | | Location: | S |
|---|---|---|---|--|---|---|---|---|---|
| | | Total Cost: \$ | 1850.00 |) | Obstruction Type | | | Storm Grate/Utility Type | |
