## Access Compliance Report Public Rights-of-Way (Curb Ramps)

Intersection ID: 17467 Main Street: CROYDON\_RD Cross Street: STERLING\_RD Location: NW

ADA ID: 0B37D8E5CE89 Ramp Type: PerpDiag Initial Pass/Fail: Fail Overall Compliance: No Severity Score: 13.75

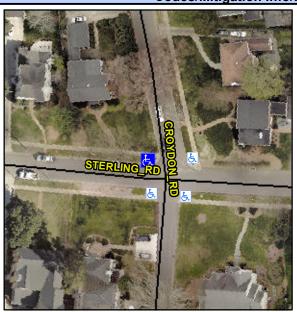
Field Measurements/Component Compliance						
	Compliance Description		Data	Comp	oliance Description	Data
	N/A	Ramp Length (in)	111.0	No	Ramp Slope (%)	8.5
	Yes	Ramp Width (in)	48.0	No	Ramp XSlope (%)	3.3
	N/A	Flare Type LT	N/A	N/A	Flare Type RT	N/A
	N/A	Flare Slope LT (%)	N/A	N/A	Flare Slope RT (%)	N/A
	N/A	Flare Traversable LT?	N/A	N/A	Flare Traversable RT?	N/A
	N/A	Landing Length (in)	N/A	N/A	DWS Provided?	N/A
	N/A	Landing Width (in)	N/A	N/A	DWS Contrast?	N/A
	N/A	Landing Slope (%)	N/A	N/A	DWS Length (in)	N/A
	N/A	Landing X Slope (%)	N/A	N/A	DWS Full Width?	N/A
	N/A	Landing Curb? (Y/N)	N/A	N/A	DWS Offset (in)	N/A
	N/A	Shared Landing?	N/A			
	N/A	Gutter Ponding?	N/A	N/A	Gutter Slope (%)	N/A
	N/A	Gutter Lip Ht (in)	N/A	N/A	Gutter X Slope (%)	N/A
	N/A	Painted X Walk1?	No	N/A	Painted X Walk2?	No
		X Walk 1 Direction	To S		X Walk 2 Direction	To SE
	N/A	X Walk 1 Width (in)	N/A	N/A	X Walk 2 Width (in)	N/A
		X Walk 1 Slope (%)	3.5		X Walk 2 Slope (%)	9.3

X Walk 1 X Slope (%)	1.3		X Walk 2 X Slope (%)	1.1
	N/A	Ramp inside XWalk1?	N/A	N/A	Ramp inside XWalk2?	N/A
		Road Slope (%)	1.7	N/A	Clear Space?	N/A
		Road X Slope (%)	9.0	N/A	Clear Space to XWalk (in)	N/A
	N/A	Any Obstructions?	N/A	N/A	Storm Grate/Utility Hazard?	N/A
		Obstruction Type			Storm Grate/Utility Type	
			N/A			N/A
				Yes	Surface Condition? (G/P)	Good
	/-20
