Access Compliance Report

Public Rights-of-Way

(Curb Ramps)

| Intersection ID: 15353 | Main Street: DILWORTH_RD_WEST | Cross Street: LEDGEWOOD_LN | Location: W |

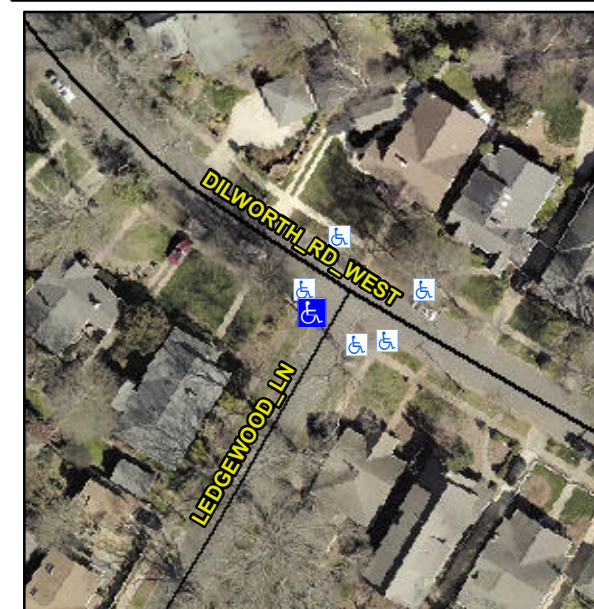
| ADA ID: 0B3DF04947A1 | Ramp Type: Perp | Initial Pass/Fail: Fail | Overall Compliance: No |
| Severity Score: 31.25 | | | |

R304.5.1, R304.2.2, R304.5.3

| Compliance | Description | Data | Compliance | Description | Data |
|---|---|---|---|---|---|
| N/A | Ramp Length (in) | 46.0 | No | Ramp Slope (%) | 8.6 |
| No | Ramp Width (in) | 32.0 | No | Ramp XSlope (%) | 2.9 |

Remove & Replace Entire Ramp.

\$ 1850.00
