Access Compliance Report Public Rights-of-Way (Curb Ramps)

Intersection ID: 27641 Main Street: BALLANTYNE_COUNTRY_CLUBrobs Street: YOUNG_POPLAR_PL Location: NE

ADA ID: 0B670A267713 Ramp Type: Perp Initial Pass/Fail: Fail Overall Compliance: No Severity Score: 26.25

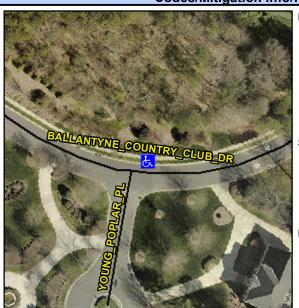
Comp	liance Description	Data	Comp	liance Description	Data
N/A	Ramp Length (in)	48.0	No	Ramp Slope (%)	13.2
Yes	Ramp Width (in)	48.0	Yes	Ramp XSlope (%)	3.6
N/A	Flare Type LT	N/A	N/A	Flare Type RT	N/A
N/A	Flare Slope LT (%)	N/A	N/A	Flare Slope RT (%)	N/A
N/A	Flare Traversable LT?	N/A	N/A	Flare Traversable RT?	N/A
N/A	Landing Length (in)	N/A	N/A	DWS Provided?	N/A
N/A	Landing Width (in)	N/A	N/A	DWS Contrast?	N/A
N/A	Landing Slope (%)	N/A	N/A	DWS Length (in)	N/A
N/A	Landing X Slope (%)	N/A	N/A	DWS Full Width?	N/A
N/A	Landing Curb? (Y/N)	N/A	N/A	DWS Offset (in)	N/A
N/A	Shared Landing?	N/A			
N/A	Gutter Ponding?	N/A	N/A	Gutter Slope (%)	N/A
N/A	Gutter Lip Ht (in)	N/A	N/A	Gutter X Slope (%)	N/A
N/A	Painted X Walk1?	No	N/A	Painted X Walk2?	N/A
	X Walk 1 Direction	To S		X Walk 2 Direction	N/A
N/A	X Walk 1 Width (in)	N/A	N/A	X Walk 2 Width (in)	N/A
	X Walk 1 Slope (%)	5.9		X Walk 2 Slope (%)	N/A
	X Walk 1 X Slope (%)	3.7		X Walk 2 X Slope (%)	N/A

N/A	Ramp inside XWalk1?	N/A	N/A	Ramp inside XWalk2?	N/A
	Road Slope (%)	N/A	N/A	Clear Space?	N/A
	Road X Slope (%)	N/A	N/A	Clear Space to XWalk (in)	N/A
N/A	Any Obstructions?	N/A	N/A	Storm Grate/Utility Hazard?	N/A
	Obstruction Type			Storm Grate/Utility Type	
		N/A			N/A
			Yes	Surface Condition? (G/P)	Good

Possible Solutions:	Con
Remove & Replace Entire Ramp.	N/A
	Yes
	N/A
	N/A
	N/A
	N/A
Surveyor Notes:	N/A
N/A	N/A
	N/A
	N/A
	N/A
PROW/ADA:	N/A
Not Found, R304.2.2	N/A
	N/A
	N/A
	N/A
