# Access Compliance Report

## Public Rights-of-Way

### (Curb Ramps)

Intersection ID: 16558	Main Street: BUCKNELL_AV	Cross Street: QUEENS_RD_WEST	Location: E
ADA ID: 0B7183F3DD01	Ramp Type: Perp	Initial Pass/Fail: Fail	Overall Compliance: No
Severity Score: 41.25			
Codes/Mitigation Info/Possible Solution		Field Measurements/Component Compliance

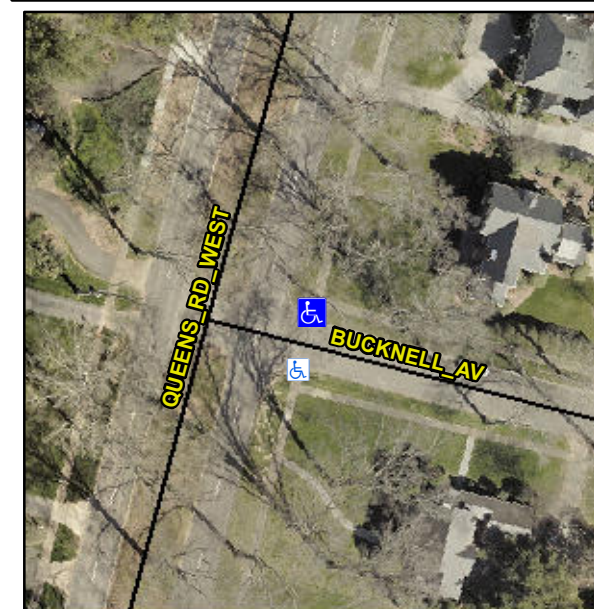
**Not Found, R304.2.2, R304.5.3, R302.7**

Compliance	Description	Data	Compliance	Description	Data
N/A	Ramp Length (in)	90.0	No	Ramp Slope (%)	12.8
Yes	Ramp Width (in)	59.5	No	Ramp XSlope (%)	4.4
N/A	Flare Type LT	N/A	N/A	Flare Type RT	N/A
N/A	Flare Slope LT (%)	N/A	N/A	Flare Slope RT (%)	N/A
N/A	Flare Traversable LT?	N/A	N/A	Flare Traversable RT?	N/A
N/A	Landing Length (in)	N/A	N/A	DWS Provided?	N/A
N/A	Landing Width (in)	N/A	N/A	DWS Contrast?	N/A
N/A	Landing Slope (%)	N/A	N/A	DWS Length (in)	N/A
N/A	Landing X Slope (%)	N/A	N/A	DWS Full Width?	N/A
N/A	Landing Curb? (Y/N)	N/A	N/A	DWS Offset (in)	N/A
N/A	Shared Landing?	N/A			
N/A	Gutter Ponding?	N/A	N/A	Gutter Slope (%)	N/A
N/A	Gutter Lip Ht (in)	N/A	N/A	Gutter X Slope (%)	N/A
N/A	Painted X Walk1?	No	N/A	Painted X Walk2?	N/A
	X Walk 1 Direction	To SW		X Walk 2 Direction	N/A
N/A	X Walk 1 Width (in)	N/A	N/A	X Walk 2 Width (in)	N/A
	X Walk 1 Slope (%)	3.4		X Walk 2 Slope (%)	N/A
	X Walk 1 X Slope (%)	0.2		X Walk 2 X Slope (%)	N/A

N/A	Ramp inside XWalk1?	N/A	N/A	Ramp inside XWalk2?	N/A
	Road Slope (%)	N/A	N/A	Clear Space?	N/A
	Road X Slope (%)	N/A	N/A	Clear Space to XWalk (in)	N/A
N/A	Any Obstructions?	N/A	N/A	Storm Grate/Utility Hazard?	N/A
	Obstruction Type			Storm Grate/Utility Type	
		N/A			N/A
		No		Surface Condition? (G/P)	Poor

Possible Solutions:

**Remove & Replace Entire Ramp.**
