Access Compliance Report

Public Rights-of-Way

(Curb Ramps)

Intersection ID: 24079	Main Street: LIVINGSTON_MILL_RD	Cross Street: MOSS_RD	Location: NW
ADA ID: 0B7674DB5CD4	Ramp Type: Perp	Initial Pass/Fail: Fail	Overall Compliance: No
Severity Score: 8.75			
Codes/Mitigation Info/Possible Solution		Field Measurements/Component Compliance

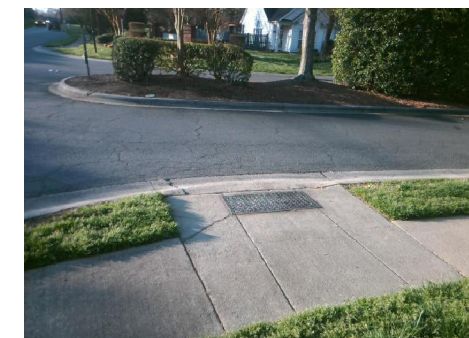
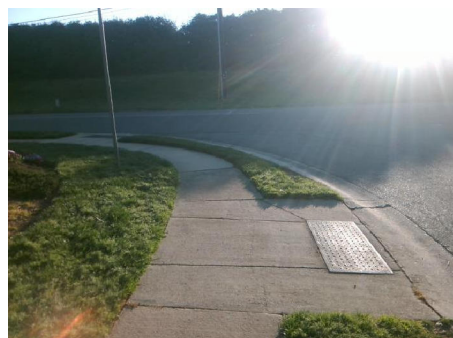
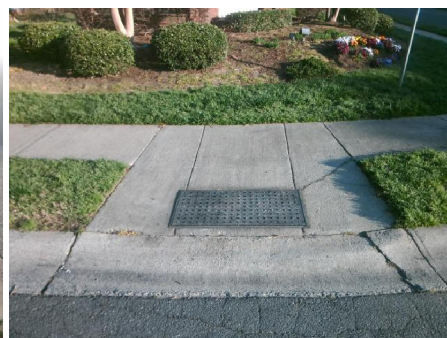
Compliance	Description	Data	Compliance	Description	Data
N/A	Ramp Length (in)	97.0	Yes	Ramp Slope (%)	5.8
No	Ramp Width (in)	44.5	Yes	Ramp XSlope (%)	0.6
N/A	Flare Type LT	N/A	N/A	Flare Type RT	N/A
N/A	Flare Slope LT (%)	N/A	N/A	Flare Slope RT (%)	N/A
N/A	Flare Traversable LT?	N/A	N/A	Flare Traversable RT?	N/A
N/A	Landing Length (in)	N/A	N/A	DWS Provided?	N/A
N/A	Landing Width (in)	N/A	N/A	DWS Contrast?	N/A
N/A	Landing Slope (%)	N/A	N/A	DWS Length (in)	N/A
N/A	Landing X Slope (%)	N/A	N/A	DWS Full Width?	N/A
N/A	Landing Curb? (Y/N)	N/A	N/A	DWS Offset (in)	N/A
N/A	Shared Landing?	N/A			
N/A	Gutter Ponding?	N/A	N/A	Gutter Slope (%)	N/A
N/A	Gutter Lip Ht (in)	N/A	N/A	Gutter X Slope (%)	N/A
N/A	Painted X Walk1?	No	N/A	Painted X Walk2?	N/A
	X Walk 1 Direction	To SE		X Walk 2 Direction	N/A
N/A	X Walk 1 Width (in)	N/A	N/A	X Walk 2 Width (in)	N/A
	X Walk 1 Slope (%)	3.2		X Walk 2 Slope (%)	N/A
	X Walk 1 X Slope (%)	0.9		X Walk 2 X Slope (%)	N/A

N/A	Ramp inside XWalk1?	N/A	N/A	Ramp inside XWalk2?	N/A
	Road Slope (%)	N/A	N/A	Clear Space?	N/A
	Road X Slope (%)	N/A	N/A	Clear Space to XWalk (in)	N/A
N/A	Any Obstructions?	N/A	N/A	Storm Grate/Utility Hazard?	N/A
	Obstruction Type			Storm Grate/Utility Type	
		N/A			N/A
			Yes	Surface Condition? (G/P)	Good

Possible Solutions:

Remove & Replace Entire Ramp.
