Access Compliance Report

Public Rights-of-Way

(Curb Ramps)

Intersection ID: 27432	Main Street: BALLANTYNE COMMONS PY	Cross Street: DURANT BV	Location:	SE
ADA ID: 0B8611A1373C	Ramp Type: Perp	Initial Pass/Fail: Fail	Overall Compliance: No	Severity Score: 22.5
Codes/Mitigation Info/Possible Solution			Field Measurements/Component Compliance

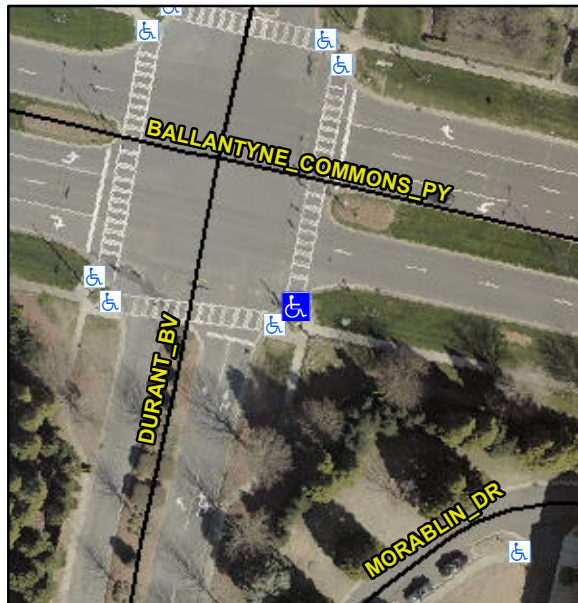
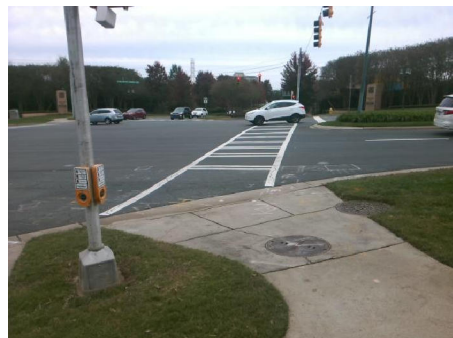
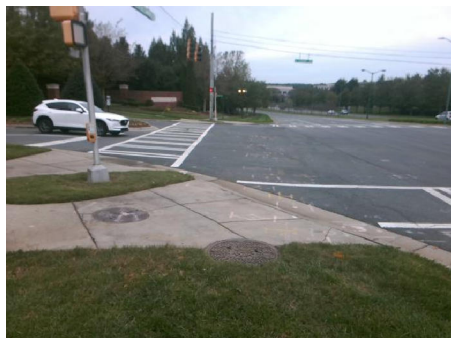
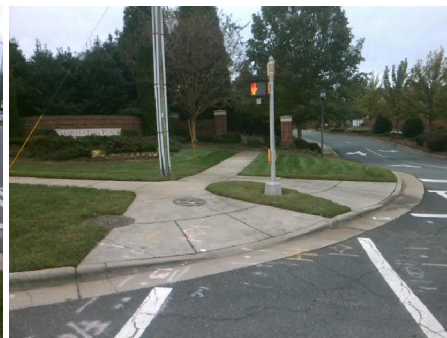
Not Found, R304.5.1

Compliance	Description	Data	Compliance	Description	Data
N/A	Ramp Length (in)	207.0	Yes	Ramp Slope (%)	11.5
No	Ramp Width (in)	44.0	Yes	Ramp XSlope (%)	4.1
N/A	Flare Type LT	N/A	N/A	Flare Type RT	N/A
N/A	Flare Slope LT (%)	N/A	N/A	Flare Slope RT (%)	N/A
N/A	Flare Traversable LT?	N/A	N/A	Flare Traversable RT?	N/A
N/A	Landing Length (in)	N/A	N/A	DWS Provided?	N/A
N/A	Landing Width (in)	N/A	N/A	DWS Contrast?	N/A
N/A	Landing Slope (%)	N/A	N/A	DWS Length (in)	N/A
N/A	Landing X Slope (%)	N/A	N/A	DWS Full Width?	N/A
N/A	Landing Curb? (Y/N)	N/A	N/A	DWS Offset (in)	N/A
N/A	Shared Landing?	N/A			
N/A	Gutter Ponding?	N/A	N/A	Gutter Slope (%)	N/A
N/A	Gutter Lip Ht (in)	N/A	N/A	Gutter X Slope (%)	N/A
N/A	Painted X Walk1?	Yes	N/A	Painted X Walk2?	N/A
	X Walk 1 Direction	To NE		X Walk 2 Direction	N/A
N/A	X Walk 1 Width (in)	117.0	N/A	X Walk 2 Width (in)	N/A
	X Walk 1 Slope (%)	0.2		X Walk 2 Slope (%)	N/A
	X Walk 1 X Slope (%)	4.7		X Walk 2 X Slope (%)	N/A

N/A	Ramp inside XWalk1?	Yes	N/A	Ramp inside XWalk2?	N/A
	Road Slope (%)	N/A	N/A	Clear Space?	N/A
	Road X Slope (%)	N/A	N/A	Clear Space to XWalk (in)	N/A
N/A	Any Obstructions?	N/A	N/A	Storm Grate/Utility Hazard?	N/A
	Obstruction Type			Storm Grate/Utility Type	
		N/A			N/A
			Yes	Surface Condition? (G/P)	Good

Possible Solutions:

Remove & Replace Entire Ramp.
