Access Compliance Report

Public Rights-of-Way

(Curb Ramps)

Intersection ID: 42513	Main Street: ELM_LN	Cross Street: INDIGO_RW	Location: S
ADA ID: 0B8E83070390	Ramp Type: PerpDiag	Initial Pass/Fail: Fail	Overall Compliance: No
Severity Score: 21.25			
Codes/Mitigation Info/Possible Solution		Field Measurements/Component Compliance

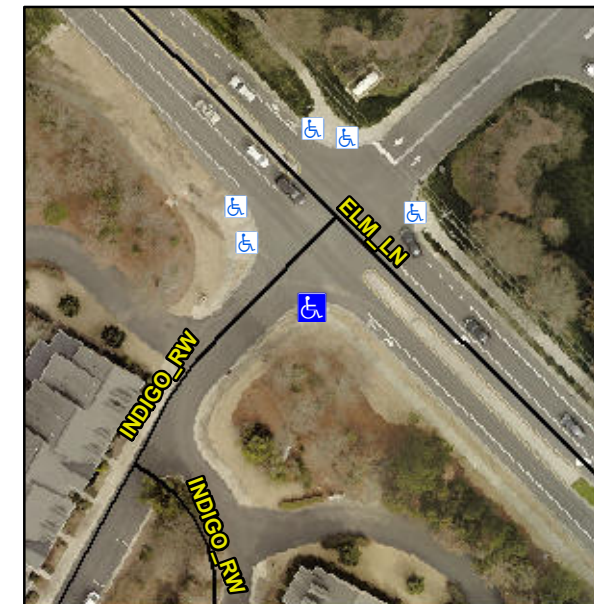
Not Found, R304.5.1, R304.2.2

Compliance	Description	Data	Compliance	Description	Data
N/A	Ramp Length (in)	47.0	No	Ramp Slope (%)	9.4
No	Ramp Width (in)	42.5	Yes	Ramp XSlope (%)	1.1
N/A	Flare Type LT	N/A	N/A	Flare Type RT	N/A
N/A	Flare Slope LT (%)	N/A	N/A	Flare Slope RT (%)	N/A
N/A	Flare Traversable LT?	N/A	N/A	Flare Traversable RT?	N/A
N/A	Landing Length (in)	N/A	N/A	DWS Provided?	N/A
N/A	Landing Width (in)	N/A	N/A	DWS Contrast?	N/A
N/A	Landing Slope (%)	N/A	N/A	DWS Length (in)	N/A
N/A	Landing X Slope (%)	N/A	N/A	DWS Full Width?	N/A
N/A	Landing Curb? (Y/N)	N/A	N/A	DWS Offset (in)	N/A
N/A	Shared Landing?	N/A			
N/A	Gutter Ponding?	N/A	N/A	Gutter Slope (%)	N/A
N/A	Gutter Lip Ht (in)	N/A	N/A	Gutter X Slope (%)	N/A
N/A	Painted X Walk1?	No	N/A	Painted X Walk2?	No
	X Walk 1 Direction	To NE		X Walk 2 Direction	To NW
N/A	X Walk 1 Width (in)	N/A	N/A	X Walk 2 Width (in)	N/A
	X Walk 1 Slope (%)	2.1		X Walk 2 Slope (%)	0.6
	X Walk 1 X Slope (%)	0.3		X Walk 2 X Slope (%)	3.8

N/A	Ramp inside XWalk1?	N/A	N/A	Ramp inside XWalk2?	N/A
	Road Slope (%)	3.7	N/A	Clear Space?	N/A
	Road X Slope (%)	1.4	N/A	Clear Space to XWalk (in)	N/A
N/A	Any Obstructions?	N/A	N/A	Storm Grate/Utility Hazard?	N/A
	Obstruction Type			Storm Grate/Utility Type	
		N/A			N/A
			Yes	Surface Condition? (G/P)	Good

Possible Solutions:

Remove & Replace Curb Ramp With Two New Directional Ramps or Equivalent.

Total Cost: \$ 3200.00
