Access Compliance Report

Public Rights-of-Way

(Curb Ramps)

Intersection ID: 12017	Main Street: S_I-77_EXIT_10A_RA	Cross Street: W_MOREHEAD_ST	Location: NW
ADA ID: 0B90C410406C	Ramp Type: Perp	Initial Pass/Fail: Pass	Overall Compliance: No
		Severity Score: 20

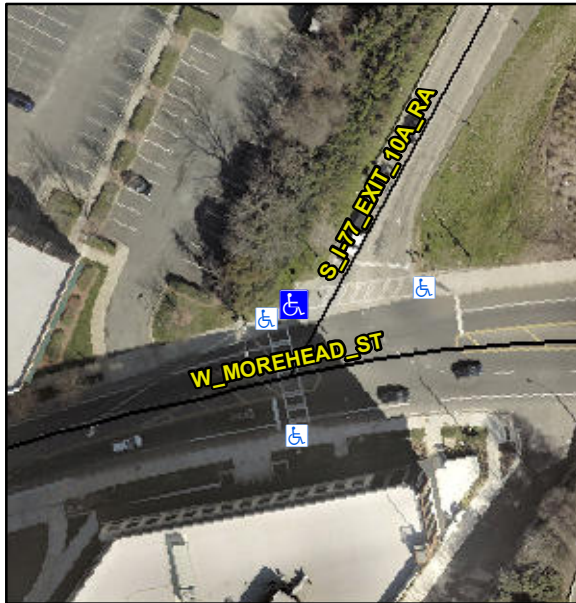
Compliance	Description	Data	Compliance	Description	Data
N/A	Ramp Length (in)	53.5	Yes	Ramp Slope (%)	5.2
Yes	Ramp Width (in)	56.0	Yes	Ramp XSlope (%)	0.7
N/A	Flare Type LT	None	N/A	Flare Type RT	N/A
N/A	Flare Slope LT (%)	N/A	Yes	Flare Slope RT (%)	5.4
N/A	Flare Traversable LT?	N/A	N/A	Flare Traversable RT?	Yes
No	Landing Length (in)	N/A	No	DWS Provided?	No
No	Landing Width (in)	N/A	N/A	DWS Contrast?	No
No	Landing Slope (%)	N/A	N/A	DWS Length (in)	N/A
No	Landing X Slope (%)	N/A	N/A	DWS Full Width?	No
N/A	Landing Curb? (Y/N)	No	N/A	DWS Offset (in)	N/A
N/A	Shared Landing?	No			
Yes	Gutter Ponding?	No	Yes	Gutter Slope (%)	0.5
Yes	Gutter Lip Ht (in)	0.0	Yes	Gutter X Slope (%)	1.2
N/A	Painted X Walk1?	No	N/A	Painted X Walk2?	N/A
	X Walk 1 Direction	To E		X Walk 2 Direction	N/A
N/A	X Walk 1 Width (in)	N/A	N/A	X Walk 2 Width (in)	N/A
	X Walk 1 Slope (%)	1.8		X Walk 2 Slope (%)	N/A
	X Walk 1 X Slope (%)	0.2		X Walk 2 X Slope (%)	N/A

N/A	Ramp inside XWalk1?	N/A	N/A	Ramp inside XWalk2?	N/A
	Road Slope (%)	N/A	N/A	Clear Space?	Yes
	Road X Slope (%)	N/A	N/A	Clear Space to XWalk (in)	N/A
Yes	Any Obstructions?	No	Yes	Storm Grate/Utility Hazard?	No
	Obstruction Type			Storm Grate/Utility Type	
		N/A			N/A
			Yes	Surface Condition? (G/P)	Good

Possible Solutions:

Remove & Replace Entire Ramp.
