Access Compliance Report

Public Rights-of-Way

(Curb Ramps)

Intersection ID: N/A	Main Street: ORCHID_BRDIGE_RD	Cross Street: N/A	Location: S
ADA ID: 0BB88B820B67	Ramp Type: Perp	Initial Pass/Fail: Fail	Overall Compliance: No
Severity Score: 21.25			
Codes/Mitigation Info/Possible Solution		Field Measurements/Component Compliance

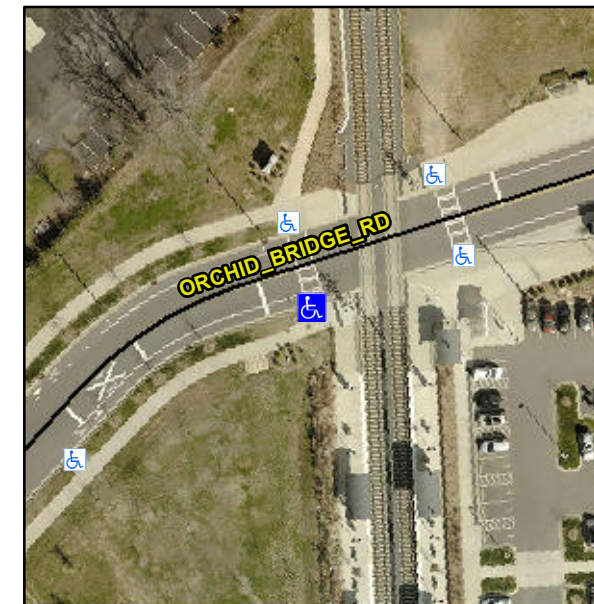
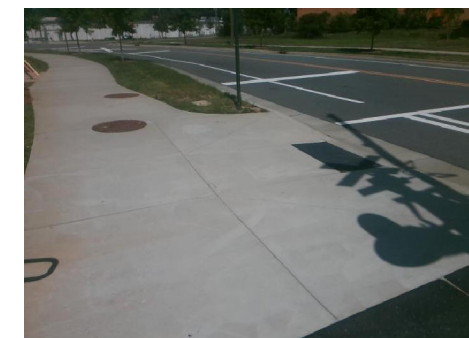
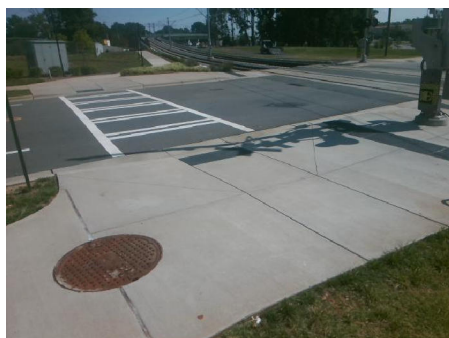
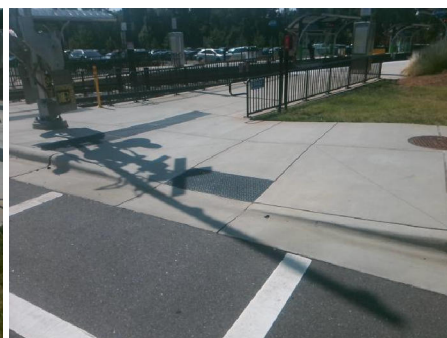
R304.5.1, R304.5.3

Compliance	Description	Data	Compliance	Description	Data
N/A	Ramp Length (in)	85.0	Yes	Ramp Slope (%)	5.2
No	Ramp Width (in)	46.5	No	Ramp XSlope (%)	6.1
N/A	Flare Type LT	N/A	N/A	Flare Type RT	N/A
N/A	Flare Slope LT (%)	N/A	N/A	Flare Slope RT (%)	N/A
N/A	Flare Traversable LT?	N/A	N/A	Flare Traversable RT?	N/A
N/A	Landing Length (in)	N/A	N/A	DWS Provided?	N/A
N/A	Landing Width (in)	N/A	N/A	DWS Contrast?	N/A
N/A	Landing Slope (%)	N/A	N/A	DWS Length (in)	N/A
N/A	Landing X Slope (%)	N/A	N/A	DWS Full Width?	N/A
N/A	Landing Curb? (Y/N)	N/A	N/A	DWS Offset (in)	N/A
N/A	Shared Landing?	N/A			
N/A	Gutter Ponding?	N/A	N/A	Gutter Slope (%)	N/A
N/A	Gutter Lip Ht (in)	N/A	N/A	Gutter X Slope (%)	N/A
N/A	Painted X Walk1?	Yes	N/A	Painted X Walk2?	N/A
	X Walk 1 Direction	To N		X Walk 2 Direction	N/A
N/A	X Walk 1 Width (in)	103.0	N/A	X Walk 2 Width (in)	N/A
	X Walk 1 Slope (%)	1.2		X Walk 2 Slope (%)	N/A
	X Walk 1 X Slope (%)	1.1		X Walk 2 X Slope (%)	N/A

N/A	Ramp inside XWalk1?	Yes	N/A	Ramp inside XWalk2?	N/A
	Road Slope (%)	N/A	N/A	Clear Space?	N/A
	Road X Slope (%)	N/A	N/A	Clear Space to XWalk (in)	N/A
N/A	Any Obstructions?	N/A	N/A	Storm Grate/Utility Hazard?	N/A
	Obstruction Type			Storm Grate/Utility Type	
		N/A			N/A
			Yes	Surface Condition? (G/P)	Good

Possible Solutions:

Remove & Replace Entire Ramp.

Total Cost: \$ 1850.00
