Access Compliance Report

Public Rights-of-Way

(Curb Ramps)

Intersection ID: 15956	Main Street: POINDEXTER_DR	Cross Street: SEDGEFIELD_RD	Location: E
ADA ID: 0BB9D280AE96	Ramp Type: Directional1	Initial Pass/Fail: Fail	Overall Compliance: No
Severity Score: 1.25			
Codes/Mitigation Info/Possible Solution		Field Measurements/Component Compliance

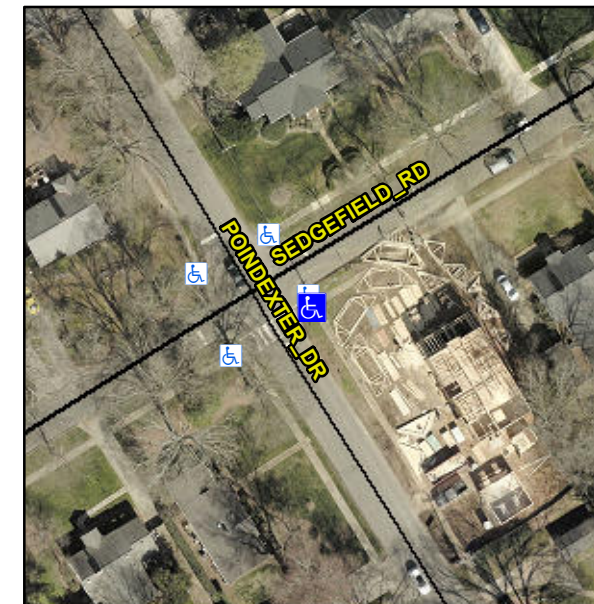
NO CURB

R304.5.3

Compliance	Description	Data	Compliance	Description	Data
N/A	Ramp Length (in)	106.0	N/A	Grade Break?	N/A
Yes	Ramp Width (in)	48.0	N/A	Grade Break Slope (%)	0.0
Yes	Ramp Slope (%)	8.3	N/A	Grade Break XSlope (%)	0.0
No	Ramp XSlope (%)	3.1			
N/A	Flare Type LT	N/A	N/A	Flare Type RT	N/A
N/A	Flare Slope LT (%)	N/A	N/A	Flare Slope RT (%)	0.0
N/A	Flare Traversable LT?	N/A	N/A	Flare Traversable RT?	N/A
N/A	Landing Length (in)	0.0	N/A	DWS Provided?	N/A
N/A	Landing Width (in)	0.0	N/A	DWS Contrast?	N/A
N/A	Landing Slope (%)	0.0	N/A	DWS Length (in)	N/A
N/A	Landing X Slope (%)	0.0	N/A	DWS Full Width?	N/A
N/A	Landing Curb? (Y/N)	N/A	N/A	DWS Offset LT (in)	N/A
N/A	Shared Landing?	N/A	N/A	DWS Offset RT (in)	N/A
N/A	Gutter Ponding?	0.0	N/A	Gutter Slope (%)	N/A
N/A	Gutter Lip Ht (in)	0.0	N/A	Gutter X Slope (%)	N/A
N/A	Painted X Walk1?	Yes		Road Slope (%)	1.9
	X Walk 1 Direction	To SW		Road X Slope (%)	2.5
	X Walk 1 Width (in)	113.0		Clear Space?	N/A

X Walk 1 Slope (%)	1.9	N/A	Clear Space to XWalk (in)	N/A
	X Walk 1 X Slope (%)	2.5	N/A	Storm Grate/Utility Hazard?	N/A
N/A	Ramp inside XWalk1?	Yes		Storm Grate/Utility Type	
N/A	Any Obstructions?	N/A			N/A
	Obstruction Type		Yes	Surface Condition? (G/P)	Good
			N/A	Curb Slope (%)	N/A

Remove & Replace Entire Ramp.
