Access Compliance Report

Public Rights-of-Way

(Curb Ramps)

Intersection ID: 27595	Main Street: BALLANTYNE COMMONS PY	Cross Street: BALLANTYNE MEADOWS DR	Location: S
ADA ID: 0BCD60C35264	Ramp Type: Perp	Initial Pass/Fail: Fail	Overall Compliance: No
Severity Score: 10			
Codes/Mitigation Info/Possible Solution		Field Measurements/Component Compliance

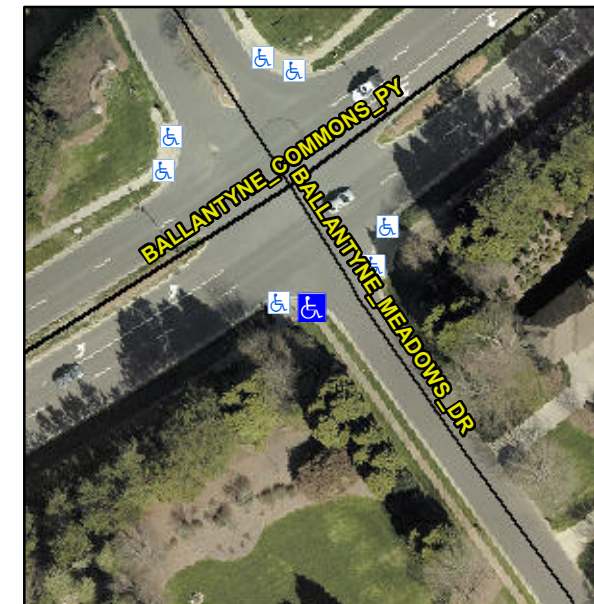
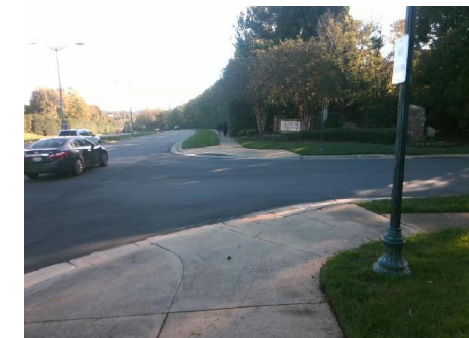
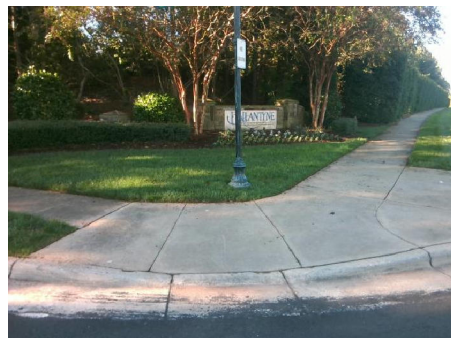
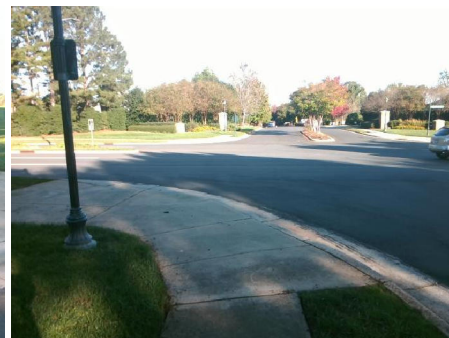
Not Found, R304.5.1, R304.5.3

Compliance	Description	Data	Compliance	Description	Data
N/A	Ramp Length (in)	84.0	Yes	Ramp Slope (%)	8.1
No	Ramp Width (in)	44.0	No	Ramp XSlope (%)	2.3
N/A	Flare Type LT	N/A	N/A	Flare Type RT	N/A
N/A	Flare Slope LT (%)	N/A	N/A	Flare Slope RT (%)	N/A
N/A	Flare Traversable LT?	N/A	N/A	Flare Traversable RT?	N/A
N/A	Landing Length (in)	N/A	N/A	DWS Provided?	N/A
N/A	Landing Width (in)	N/A	N/A	DWS Contrast?	N/A
N/A	Landing Slope (%)	N/A	N/A	DWS Length (in)	N/A
N/A	Landing X Slope (%)	N/A	N/A	DWS Full Width?	N/A
N/A	Landing Curb? (Y/N)	N/A	N/A	DWS Offset (in)	N/A
N/A	Shared Landing?	N/A			
N/A	Gutter Ponding?	N/A	N/A	Gutter Slope (%)	N/A
N/A	Gutter Lip Ht (in)	N/A	N/A	Gutter X Slope (%)	N/A
N/A	Painted X Walk1?	No	N/A	Painted X Walk2?	N/A
	X Walk 1 Direction	To NE		X Walk 2 Direction	N/A
N/A	X Walk 1 Width (in)	N/A	N/A	X Walk 2 Width (in)	N/A
	X Walk 1 Slope (%)	2.8		X Walk 2 Slope (%)	N/A
	X Walk 1 X Slope (%)	0.9		X Walk 2 X Slope (%)	N/A

N/A	Ramp inside XWalk1?	N/A	N/A	Ramp inside XWalk2?	N/A
	Road Slope (%)	N/A	N/A	Clear Space?	N/A
	Road X Slope (%)	N/A	N/A	Clear Space to XWalk (in)	N/A
N/A	Any Obstructions?	N/A	N/A	Storm Grate/Utility Hazard?	N/A
	Obstruction Type			Storm Grate/Utility Type	
		N/A			N/A
			Yes	Surface Condition? (G/P)	Good

Possible Solutions:

Remove & Replace Entire Ramp.

Total Cost: \$ 1850.00
