# Access Compliance Report

## Public Rights-of-Way

### (Curb Ramps)

| Intersection ID: 10014737 | Main Street: ROCKY_RIVER_RD | Cross Street: N/A | Location: SW |

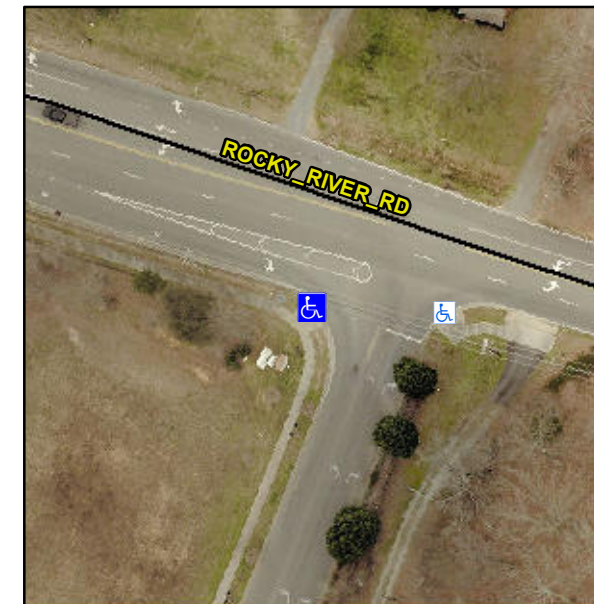
| ADA ID: 0BE1443DB670 | Ramp Type: PerpDiag | Initial Pass/Fail: Fail | Overall Compliance: No |
| | | Severity Score: 12.5 | |

**Not Found, R304.5.3**

| Compliance | Description | Data | Compliance | Description | Data |
|---|---|---|---|---|---|
| Yes | Ramp Width (in) | 50.0 | No | Ramp XSlope (%) | 5.5 |

**Remove & Replace Curb Ramp With Two New Directional Ramps or Equivalent.**

Total Cost: \$ 3200.00
